Jason Wilder

May 13, 1994

ES 102

An Analysis of Slide Areas  
at Pine Cobble Development

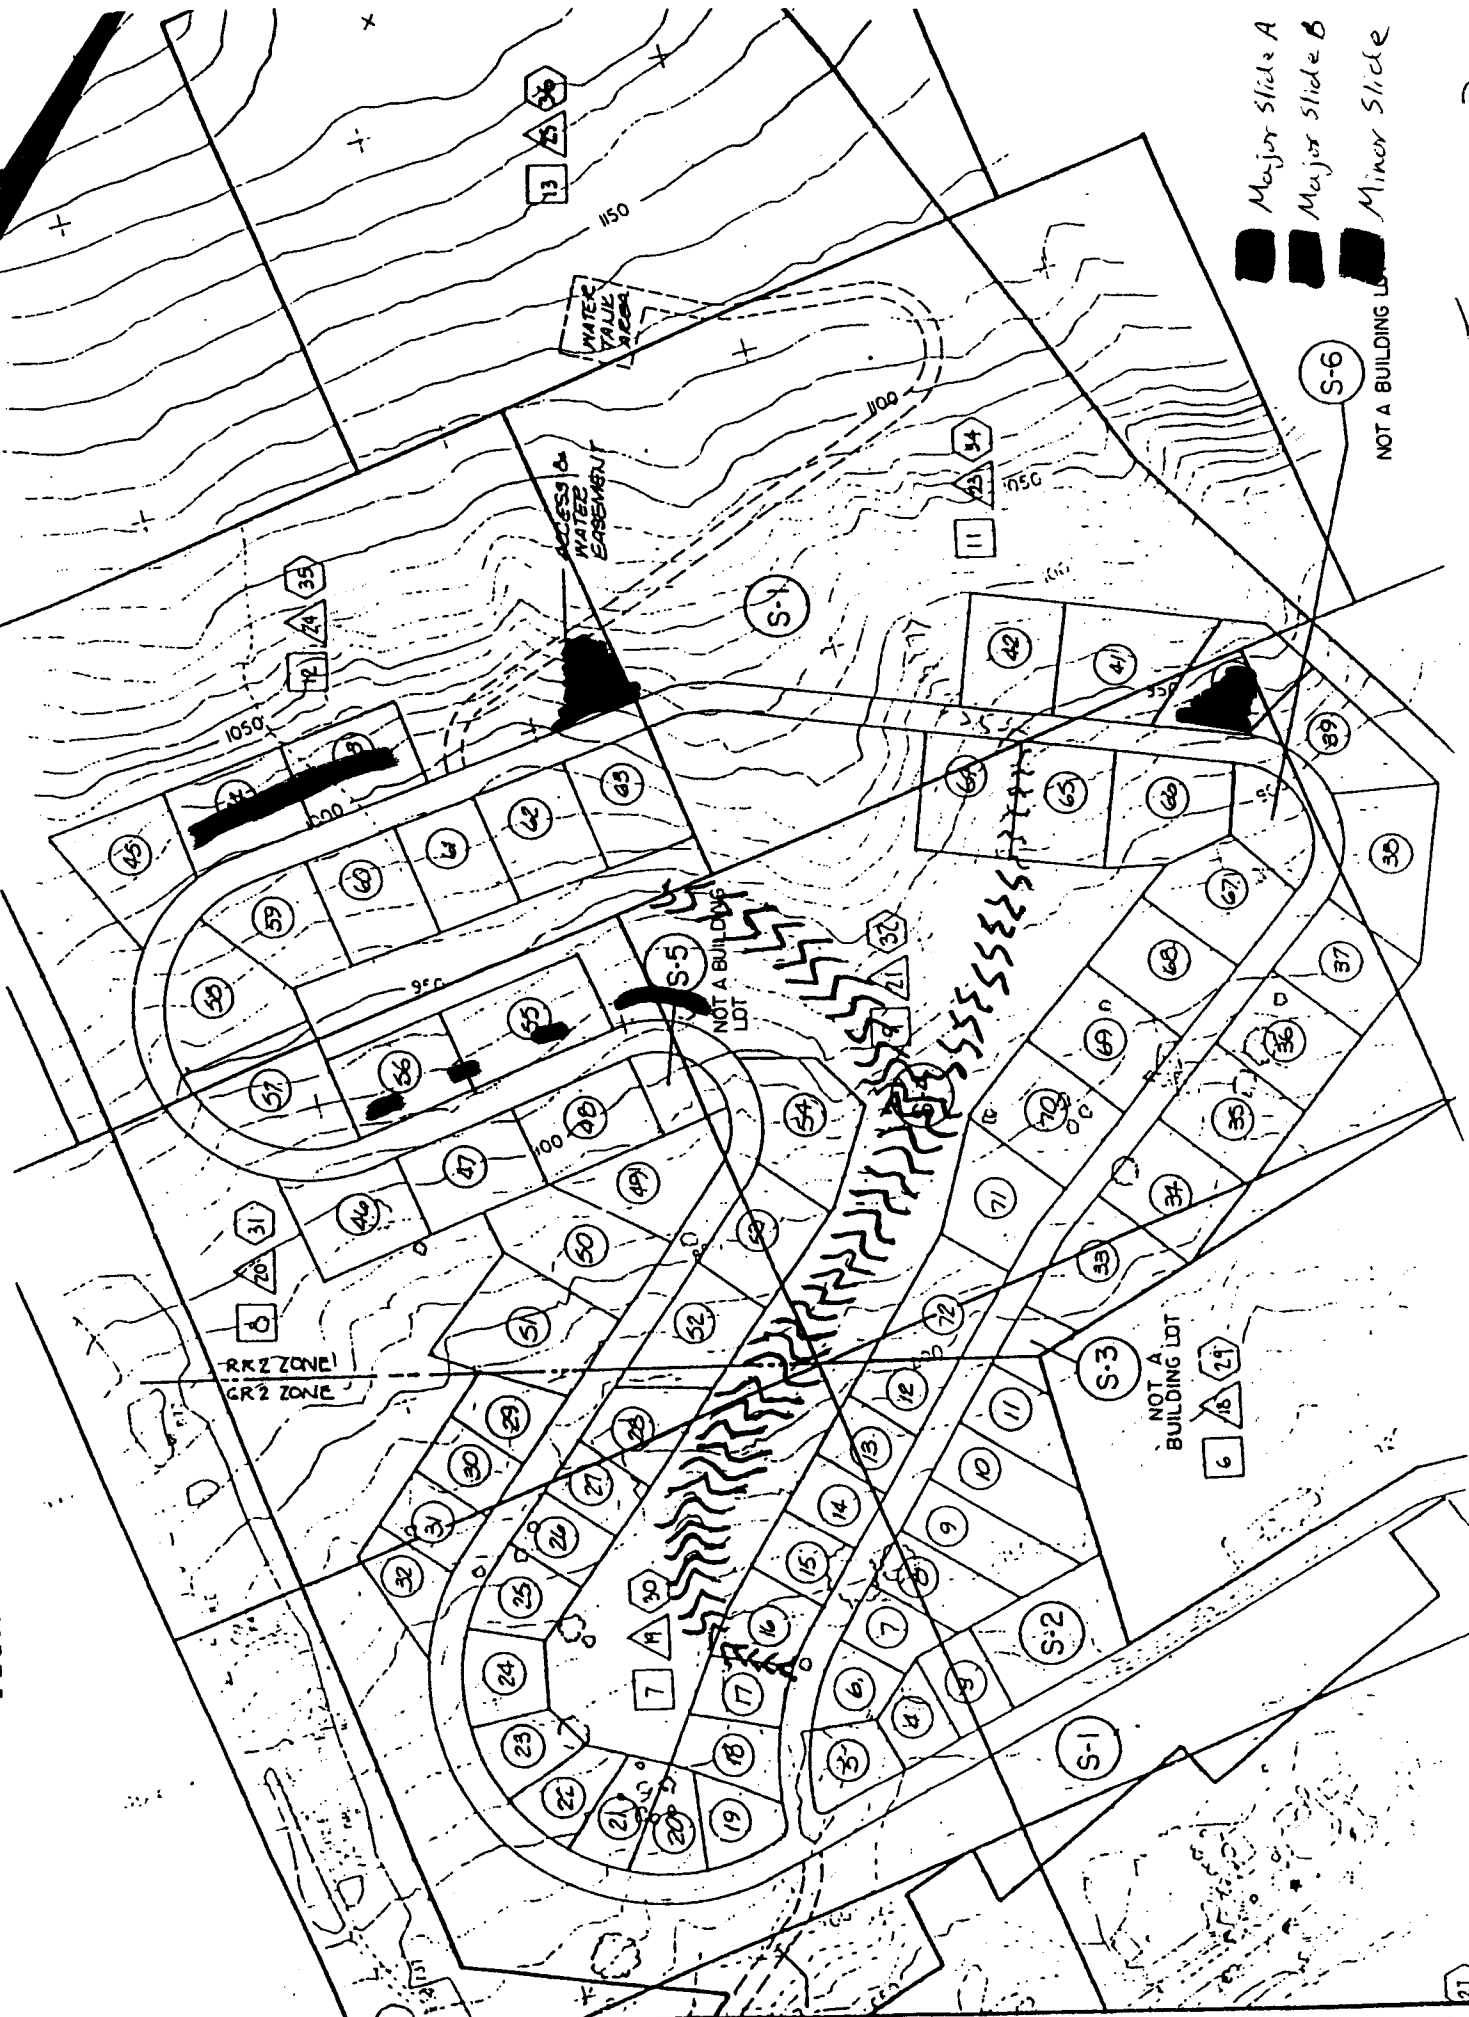
Since the road's completion a new, and potentially very costly, problem has developed. Two major mass movements of earth appeared on the upper slopes of the road. A map of the development with these slide locations is included as Figure 2. Major Slide A occurred on what was designated as a lot for housing. On this site a major slump developed. This area was engineered extensively since the area above it is now occupied by a new house. The slope is currently considered stable. The other slide, shown as Major Slide B in Figure 2, is somewhat more damaging. This slide is located between the development road and the access road to the development's water tank. This slide is currently active and is visibly undercutting the water tank access roadway. Work with vegetation and drainage is underway in an attempt to stabilize this slide before the water access road is entirely destroyed.

\* One human impact that is, to some degree, a cause of each slide is the steepening of slopes along the road embankment. As is shown by Figure 2, the major slides each occur in areas where already steep slopes were made even steeper when the road grade was cut. The areas of minor \* slides occur where the road bed runs parallel to the slope contours. The slides occur in these areas because embankment slopes are simply steepened extensions of the natural slope. These areas are slide prone since runoff and groundwater from the natural slope all flow over the steepened embankment. Embankments at road curves cut do not share this problem. The road bed cuts perpendicular to the contours of the slope at these locations, thus the embankment is steepened at an angle to the natural slope. Because of this, drainage down the embankment is not a problem. This principle is shown in Figure 2 since sections of the roadway cut parallel to the slope all show active slides, whereas road sections angling up the slope are largely inactive.

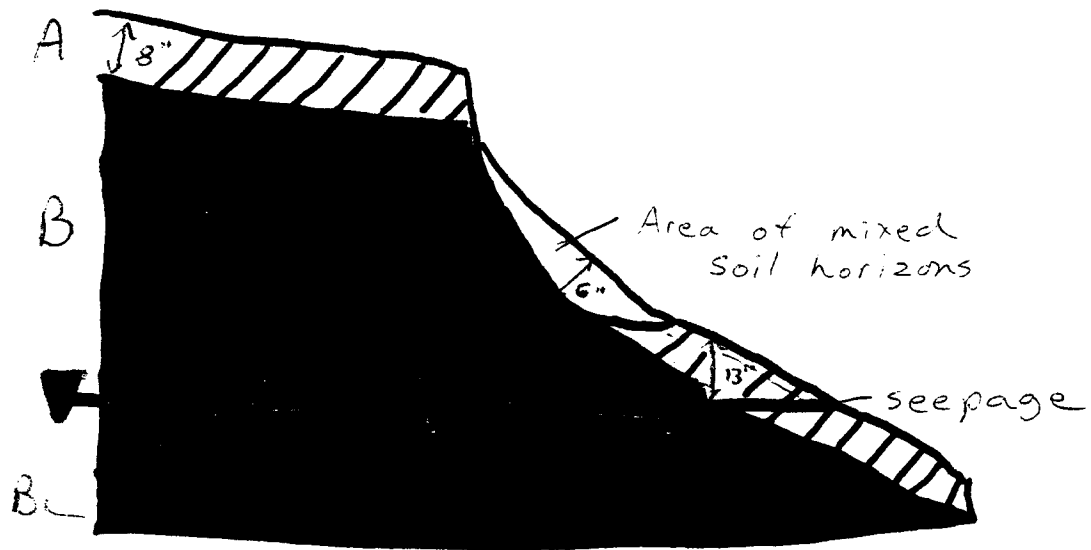
# Slide 1

Cross-sections of two slide areas can be seen in Figure 3. These two slide areas show the diversity of the slide regions studied. The first cross-section, Slide 1, shows a slide occurring over a groundwater seep. The second slide, Slide 2, shows a slide over a relatively dry slope.

Water pressure (the variable m) also seemed to be a key factor in determining active slide sites. One slide (occurring in both lots 43 and 44 on Figure 2, and shown in

cross section as Slide 1 in Figure 3) shows the effects of both groundwater and surface runoff on a steepened slope. This slope has very little vegetation over its surface. As the area above it is thickly forested, we can assume that this slope was once forested as well before the housing project was developed. This lack of vegetation not only lowers soil cohesion, but also yields a surface that is especially prone to surface runoff (an increase in the variable  $m$ ) since the slope is not directly protected by vegetation. Groundwater also plays an important key in this particular slide. Over the entire length of the slide (approximately .75 m) groundwater seepage occurred just below the slump. In addition, the slide area did not extend past the area of seepage. On the day that pits were dug at this site the water table occurred approximately 32 cm below the base of the slide. It was, however evident that this changed somewhat as several days later the table was a few centimeters higher. Despite this fluctuation in elevation the erosion patterns caused by this seepage showed that the water table had not recently risen above the level of the base of the slide. From this we can conclude that by cutting an embankment through the water table a slope failure was induced. The slide was, however, controlled to some degree by the aquifer, since the slide did not extend below the water table at any point.

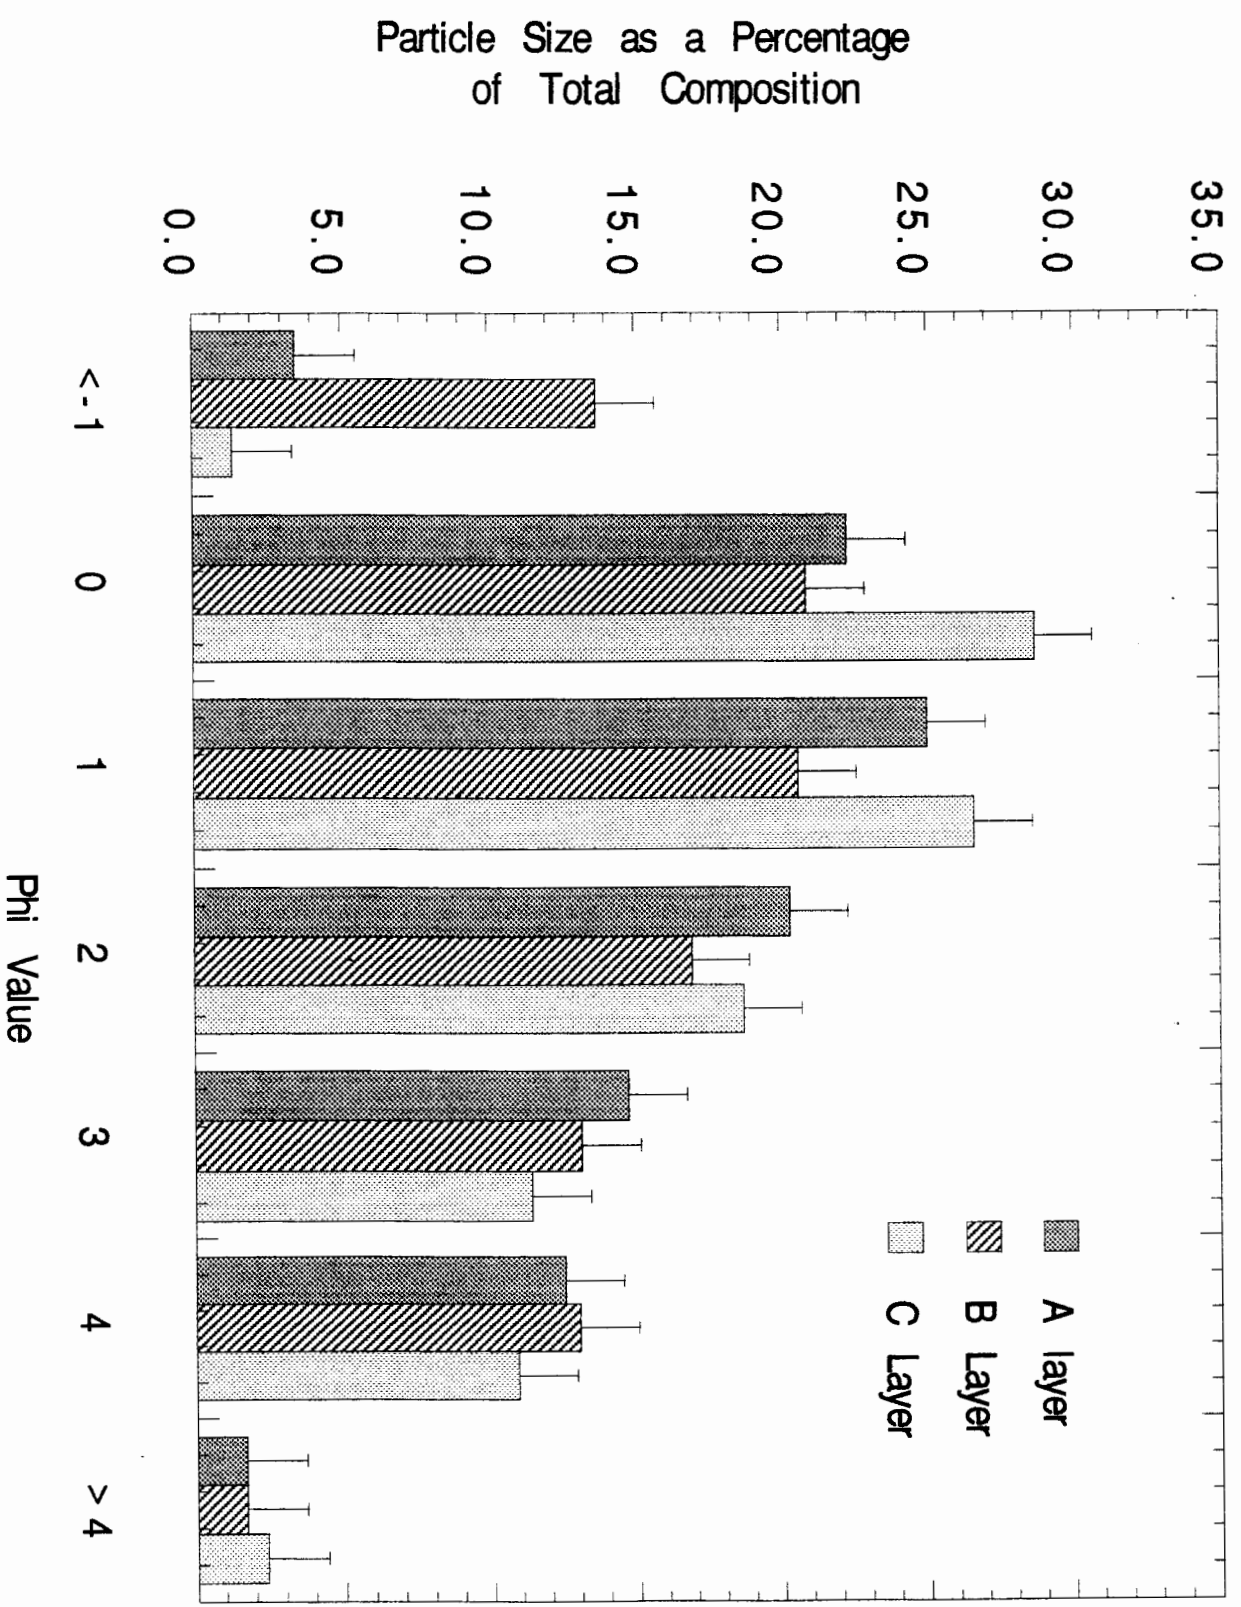
failure. Figure 4 shows a relatively uniform distribution of particle sizes over the three soil layers that were a part of the slide. Figure 5, however, shows a different slide region in which the particle sizes are not uniform at all over soil horizons. Finally, Figure 6, shows that particle sizes in a non-slide area are only somewhat uniform. Thus, it was determined that particle size uniformity over soil horizons is not an important factor in determining the likelihood of slope failure.

Relative Uniformity of Particle  
Sizes Over Soil Horizons in Slide Area

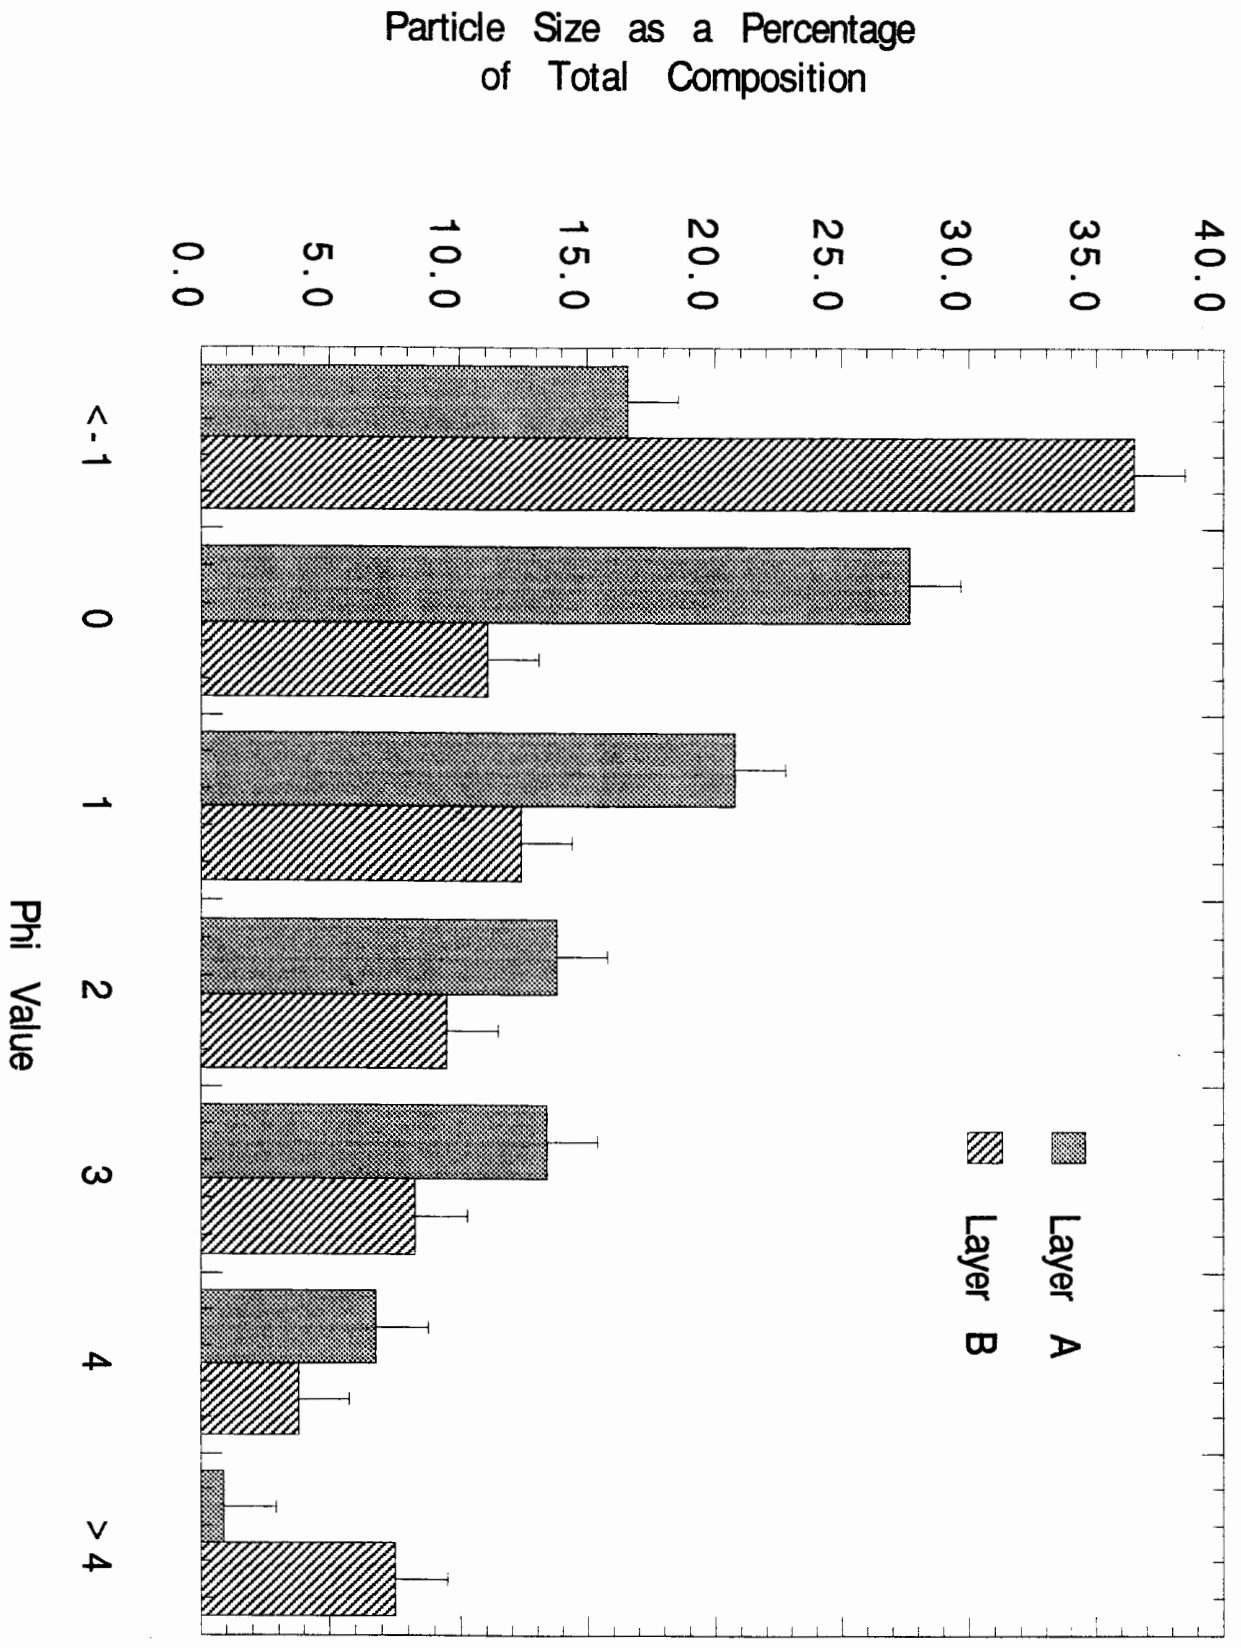
Figure 5

Lack of Uniformity Among Soil  
Layers at Slide Area

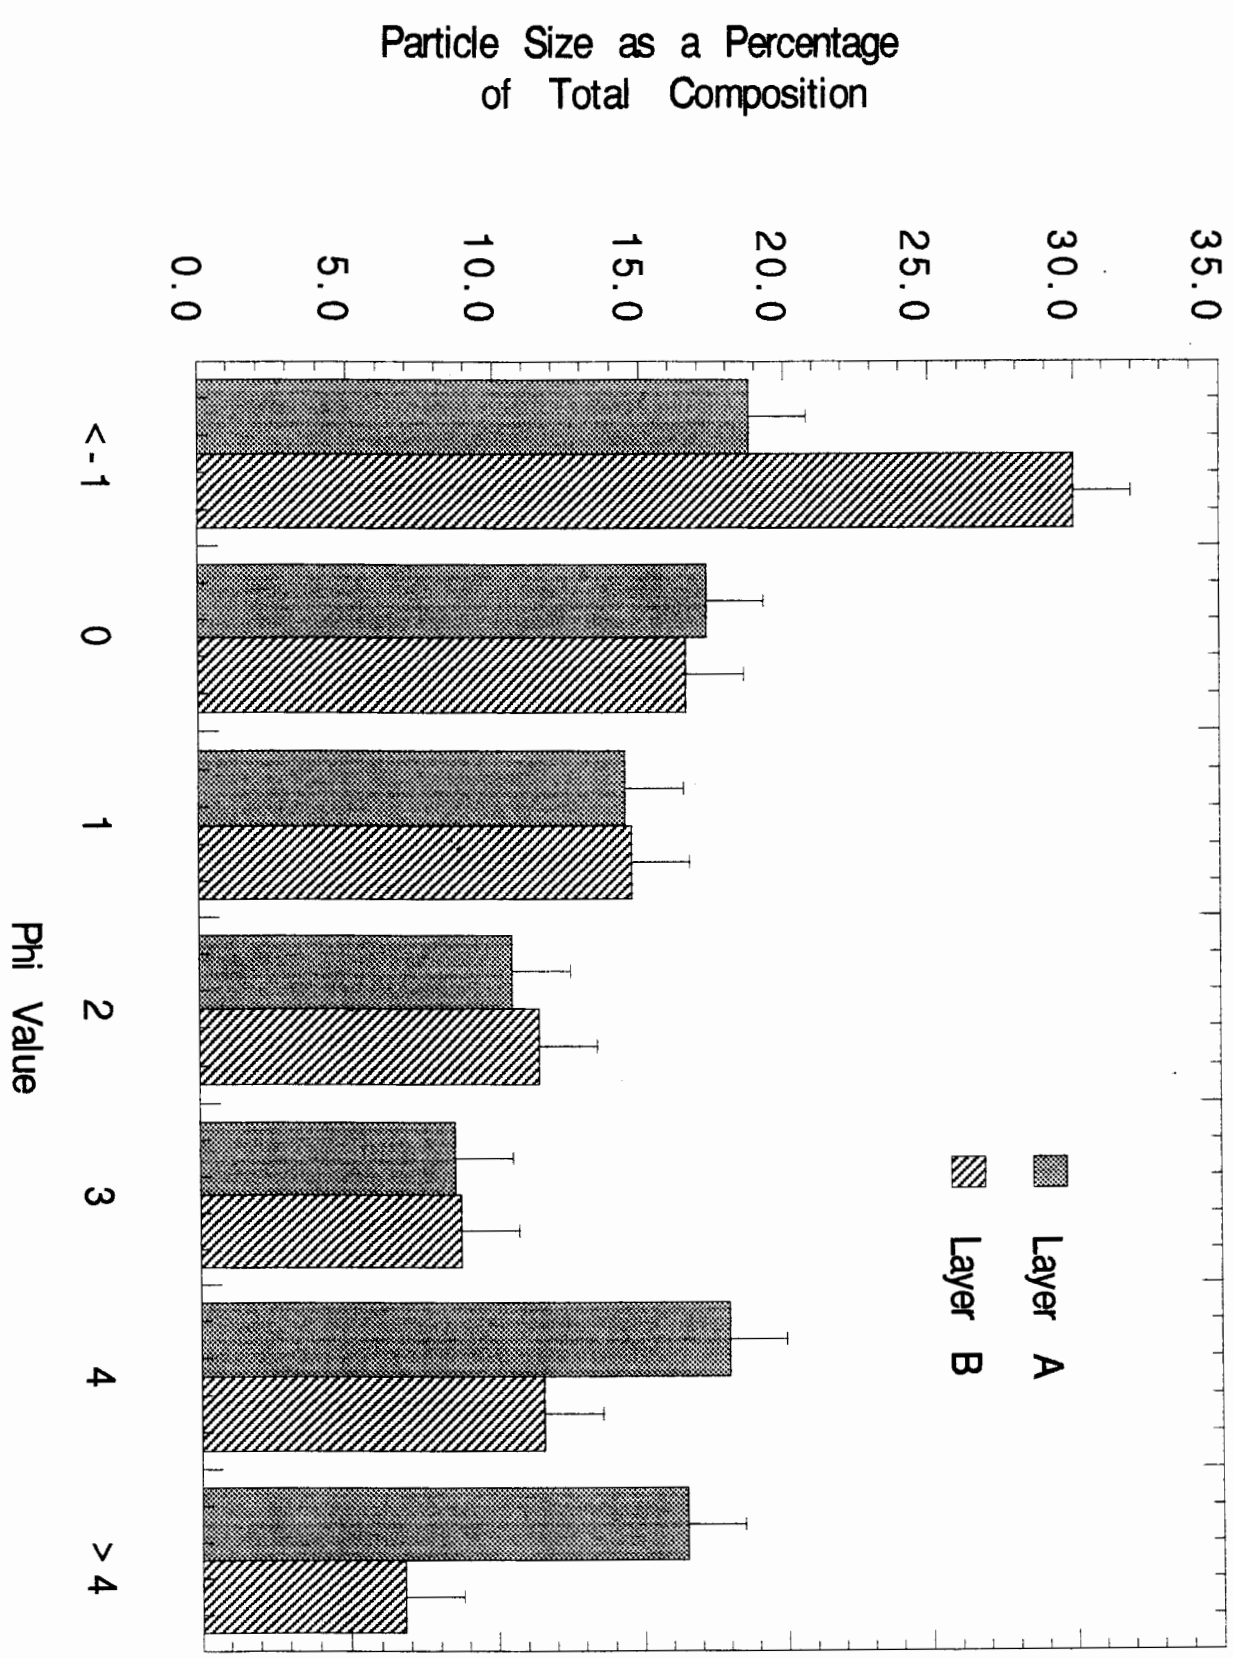
Figure 6

Somewhat Less Uniform Particle Size Distribution  
Among Soil Horizons of Non-Slide Area

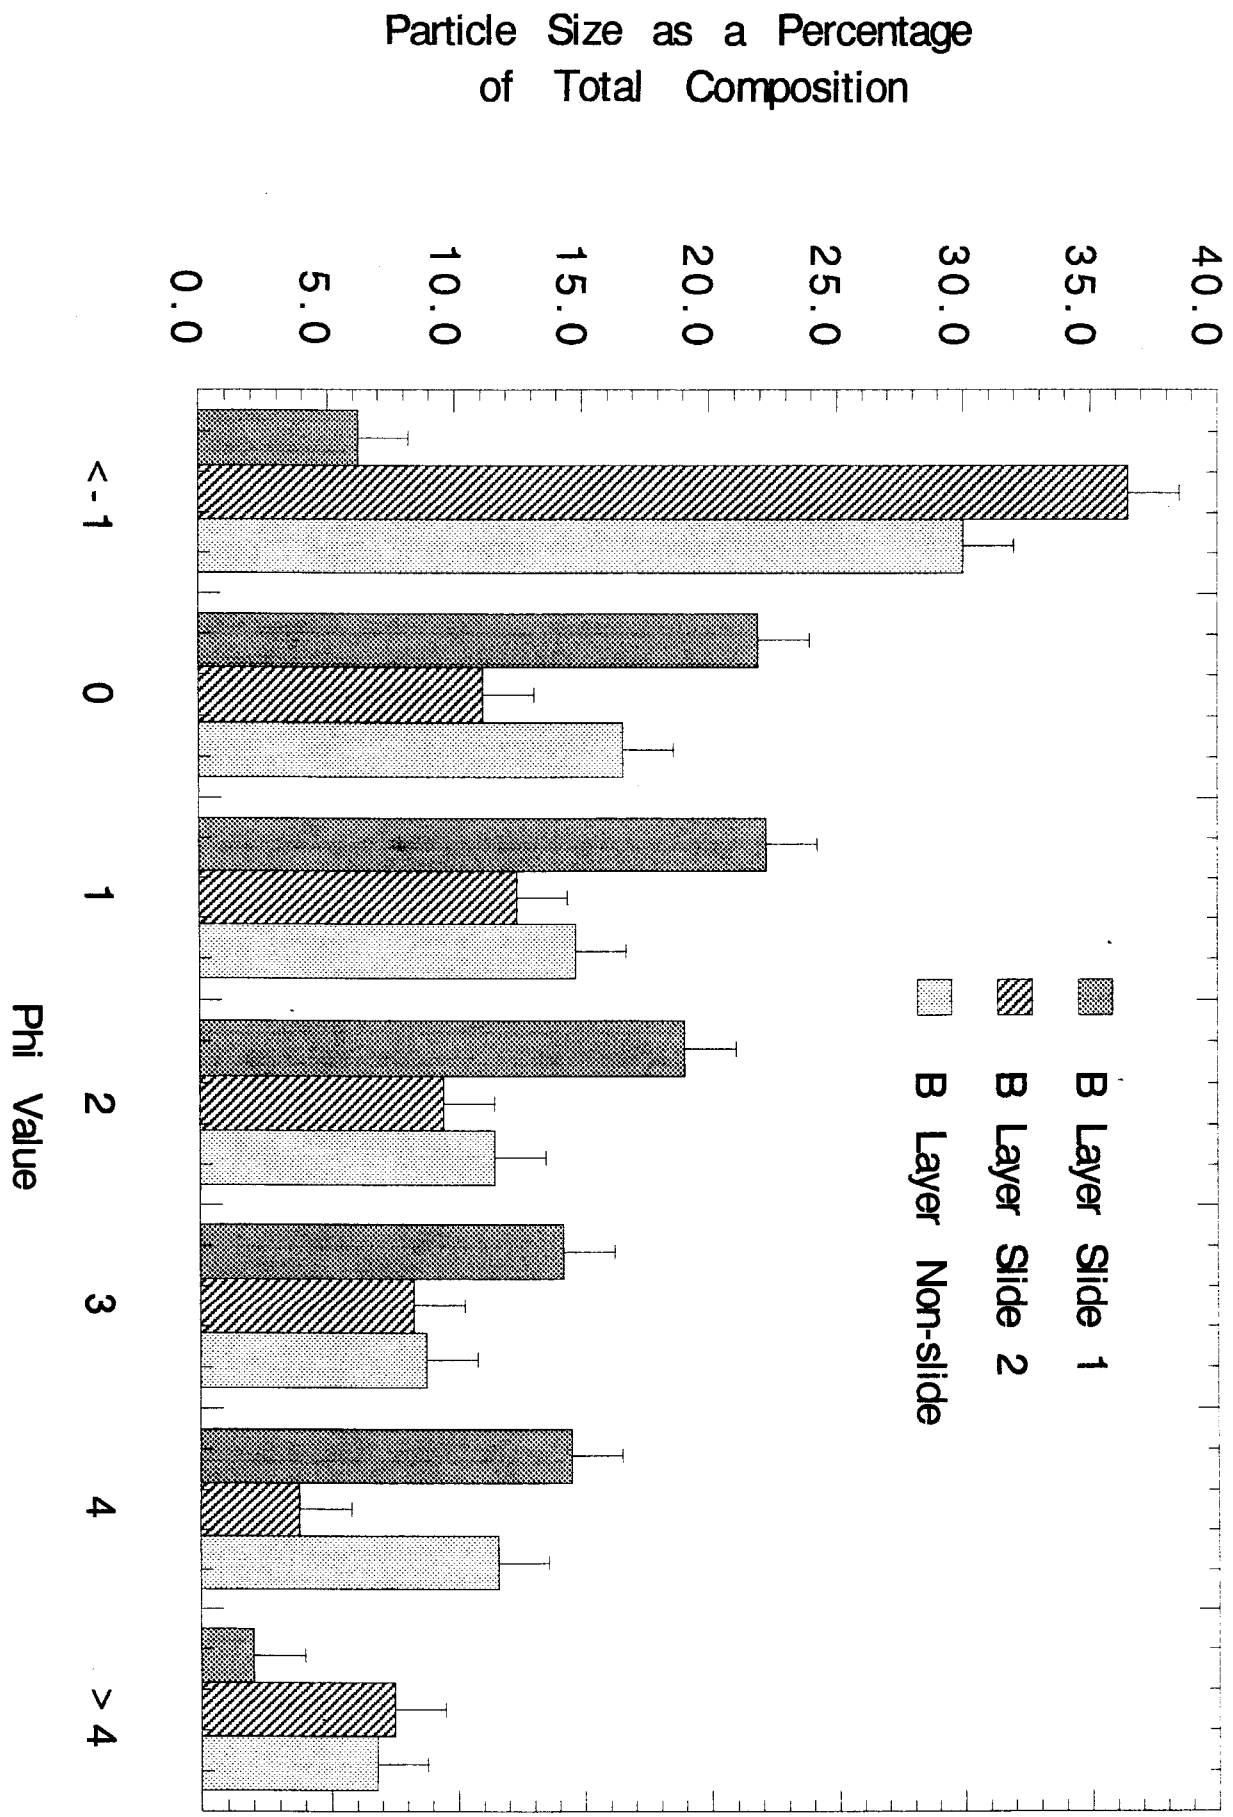
It was evident in the soil cross sections that the actual translational motion occurred in the B soil horizon. Thus particle sizes through the B layer of two slide sites and a single non-slide site were analyzed. Figure 7 shows the compositions of these B layers by particle sizes. Very little correlation was determined from this graph. A similar graph showing A layers instead of B layers can be seen in Figure 8. This graph showed an interesting trend. In the non-slide area the A horizon showed substantially higher amounts of fine silt and clay sized particles than shown to exist in the A horizons of slide sites. This is an important factor in determining which sites will develop mass movements. The increased levels of clay in non-slide sites helps to make the A layers more impermeable to water. Thus water is retained in the A layer where it is eventually used by plants or simply evaporates. In slide areas, the A horizon contains very little clay, thus the water seeps directly into the B horizon of the soil. As was shown in the slide that was

B Layers in Three Slide  
and Non-Slide Sites

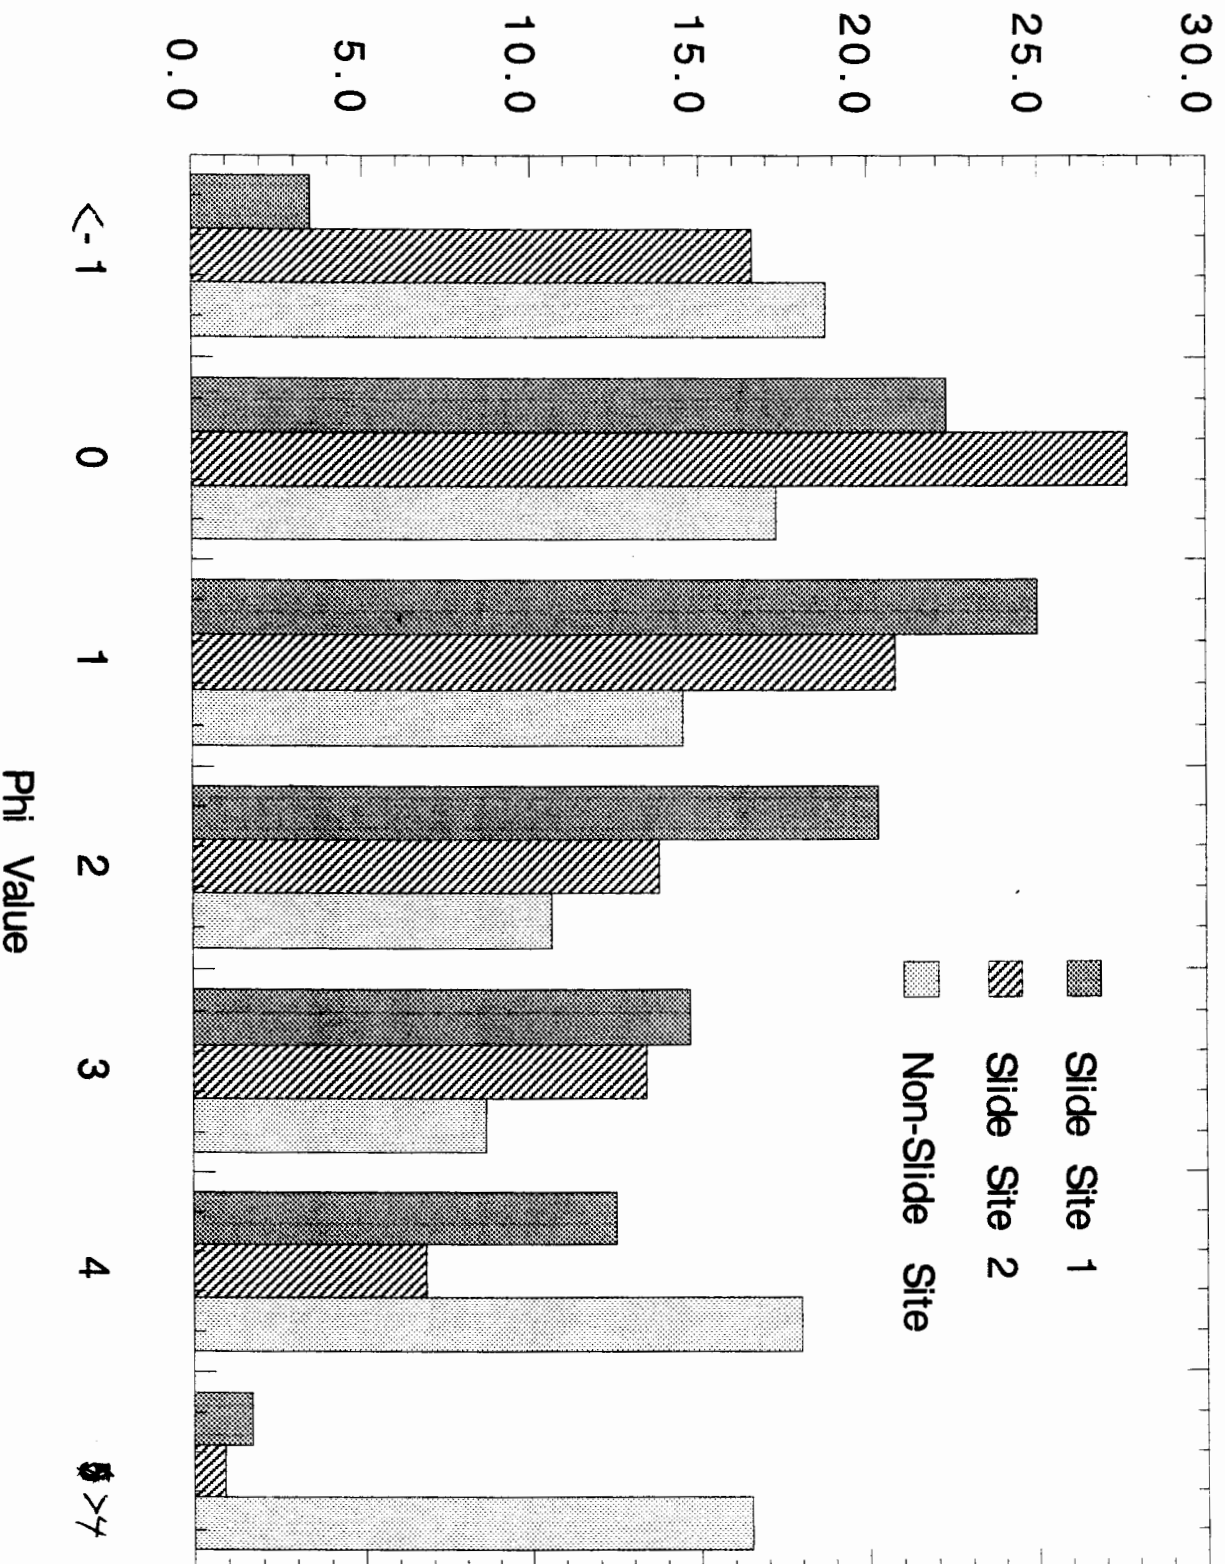
Figure 8

controlled by the elevation of the water table, ground water is an important factor in controlling slope failure. These slides that occurred in Lots 55 and 56 have higher levels of water pressure (m values) than the adjacent areas that are protected by clay in the A horizon.

# High Levels of Clay in A Horizon of Non-slide Site
