**An Observational Analysis and
Recommendations
Concerning Streamflow and Water Table
Encounters
Along the South-east Corner of the
Hopkins Forest Loop Trail**

submitted by Keely Maxwell
as an independent project
for Environmental Studies 102

May 11, 1990

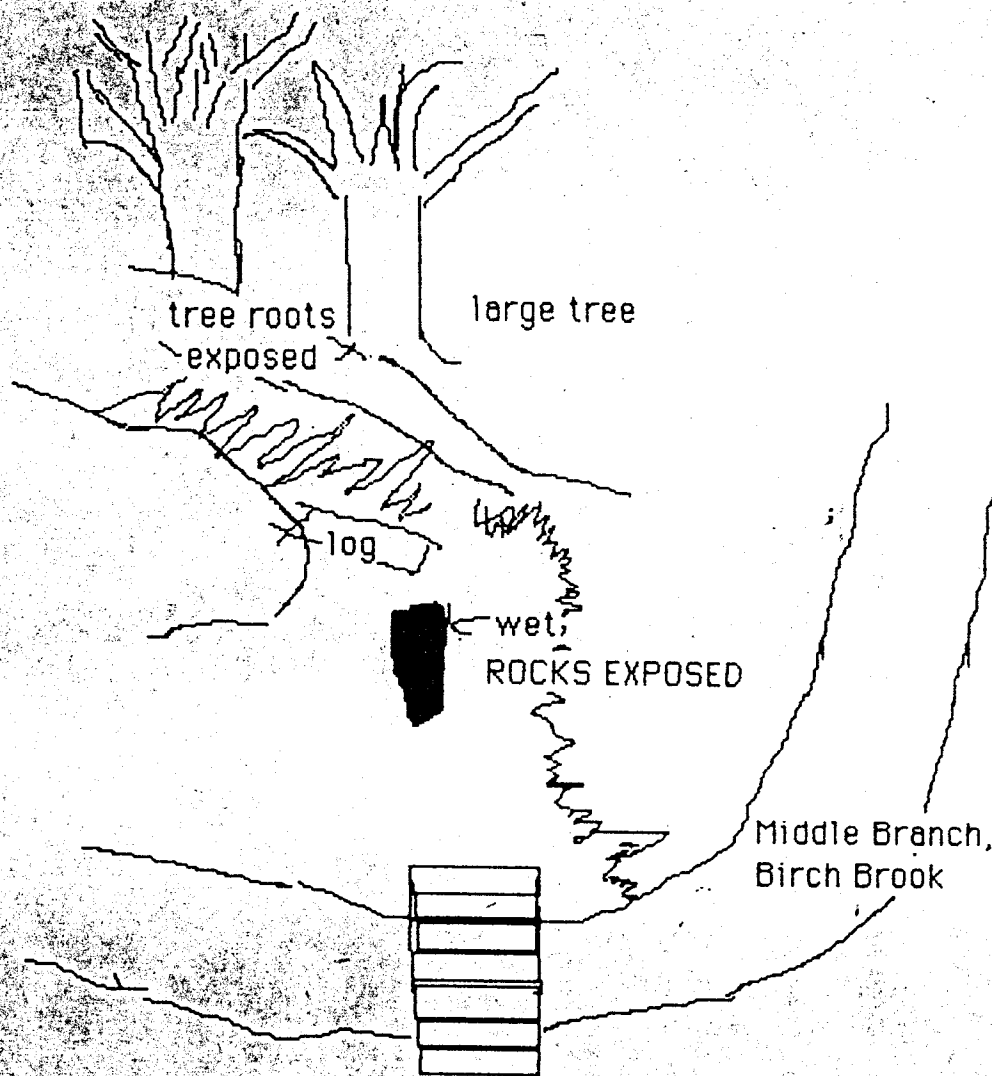
site 1

SITE 1: This is the first section encountered when travelling west on the southern end of the western loop, where the trail crosses the Middle Branch of Birch Brook for the first time. When I first went there on Sunday, April 8, 1990, there was a veritable stream running where indicated on the diagram. I measured the amount of time it took for the flow to fill a cup measure at the point where the stream emptied onto Birch Brook. That time was 10 seconds. It was rather a slow trickle. In fact, by April 16, it had dried up in the lower part, leaving wet only the upper part, where the zig-zags are wider on my diagram. The fact that the part of this water did not last even a week led me to believe that this stream was caused by seasonal runoff. The direct source of the water, I hypothesized, was the same as that for sites 2 and 3.

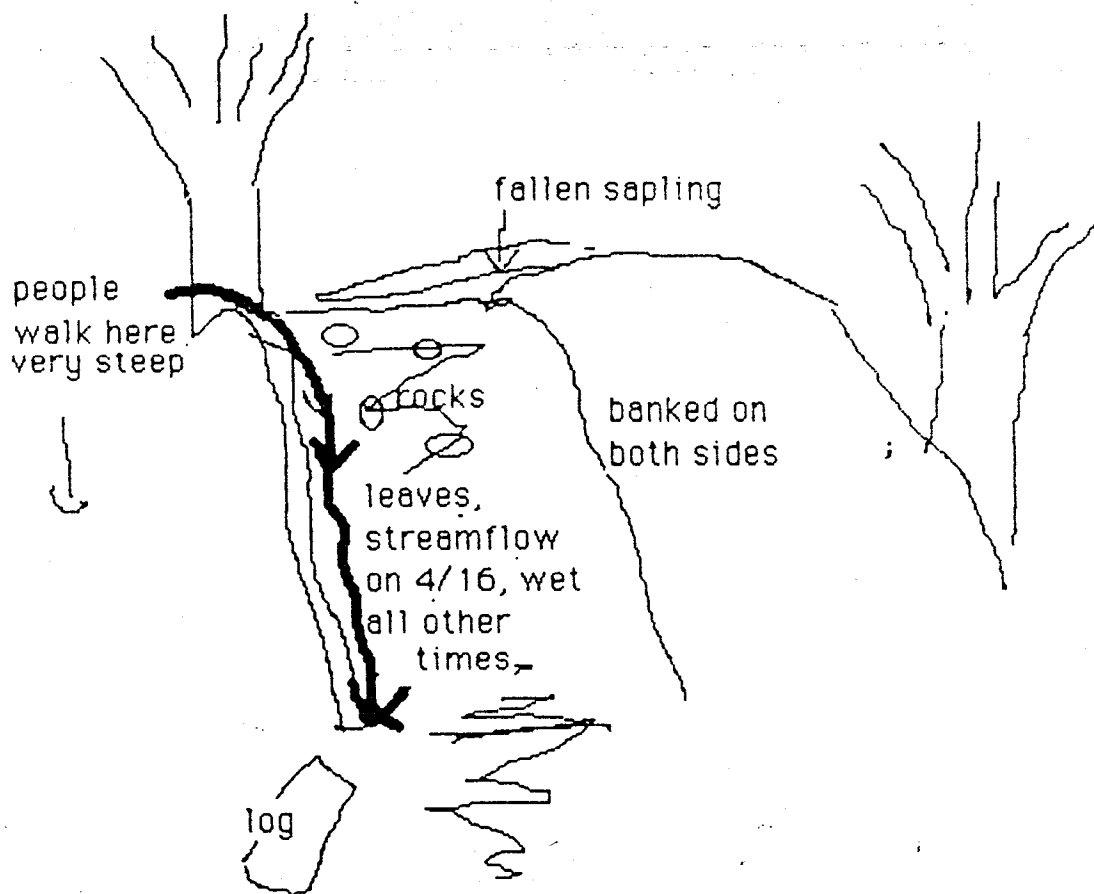
Site 2

SITE 2: This site climbs steeply through an area with high banks. If water hits the ground uphill from the trail, it can either run to the trail or else

directly to Birch Brook. Water only actually was running here until the sixteenth, at which point it became either standing or very slow moving water. Through May there was always water underneath or near the surface of the ground, sometimes hidden only by a layer of leaves. The trail as it stands in this spot is an ideal place for water to congregate because of the steep banks which do not allow any to escape once it has settled into the trail ground. Water continues around from this steep part to the wet channel in site 1, with some also running down the west side of the trail. Once this water on the western side of the trail has passed the area of steep banks, it continues in a straight line of of trail area. People have taken to travelling on the eastern side of the trail, proven by the many footprints in the mud, not all of them mine.

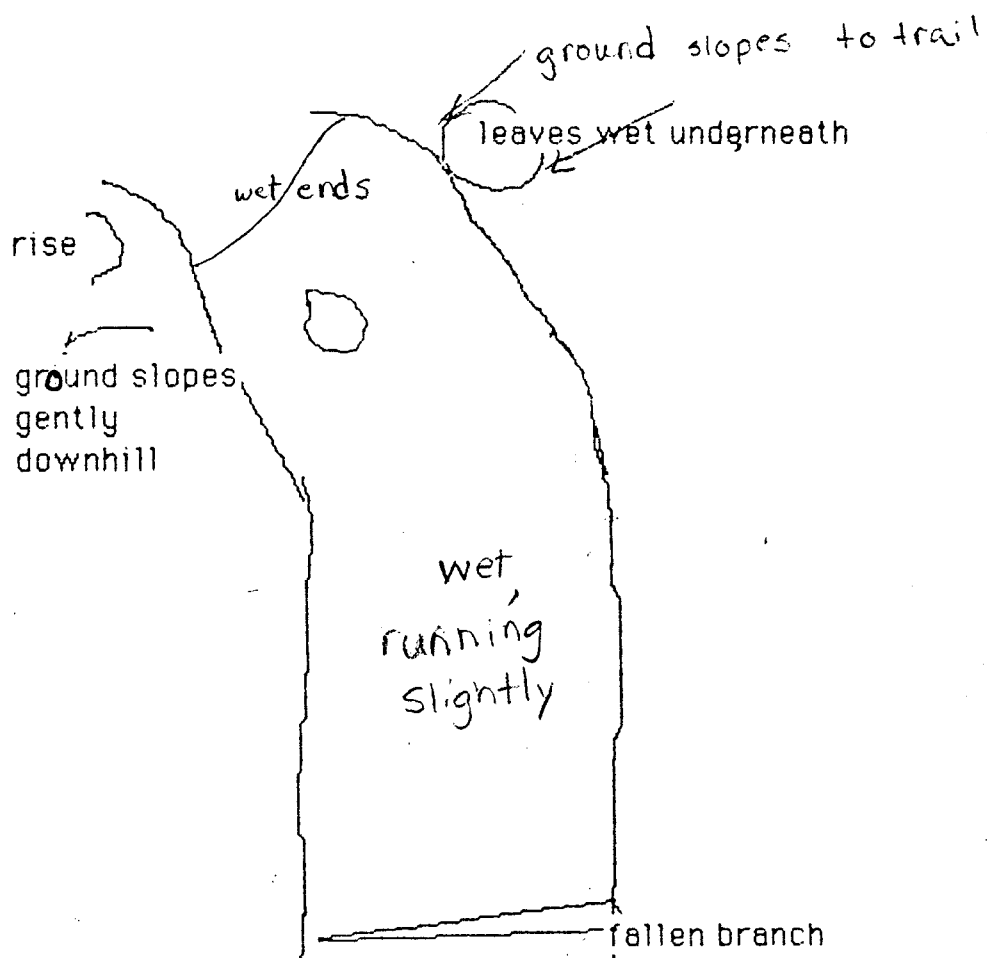
site 3

SITE 3: The wet area on this section of trail is thoroughly covered by leaves. On the uphill side, there are many trees, including fallen ones. The uphill slope rises very gradually for about 20 meters, then steepens. The source of most of the water in this area seems to be a wet patch on the uphill side, at the very beginning point from where the water began. Tracing this wet spot uphill, and there seems to be a series of wet spots all along the hill. I postulate that these spots eventually let water seep down, which collects in the trail, perhaps the trail is now a part of a localized if not general water table. This water does not exit underneath the trail because of cohesion and adhesion underneath the trail, and it does not run off above the trail because there is the slightest of rises on the downhill (east) side of the trail. Once the underground seepage inflow stops, and the trail rises slightly, it dries off.

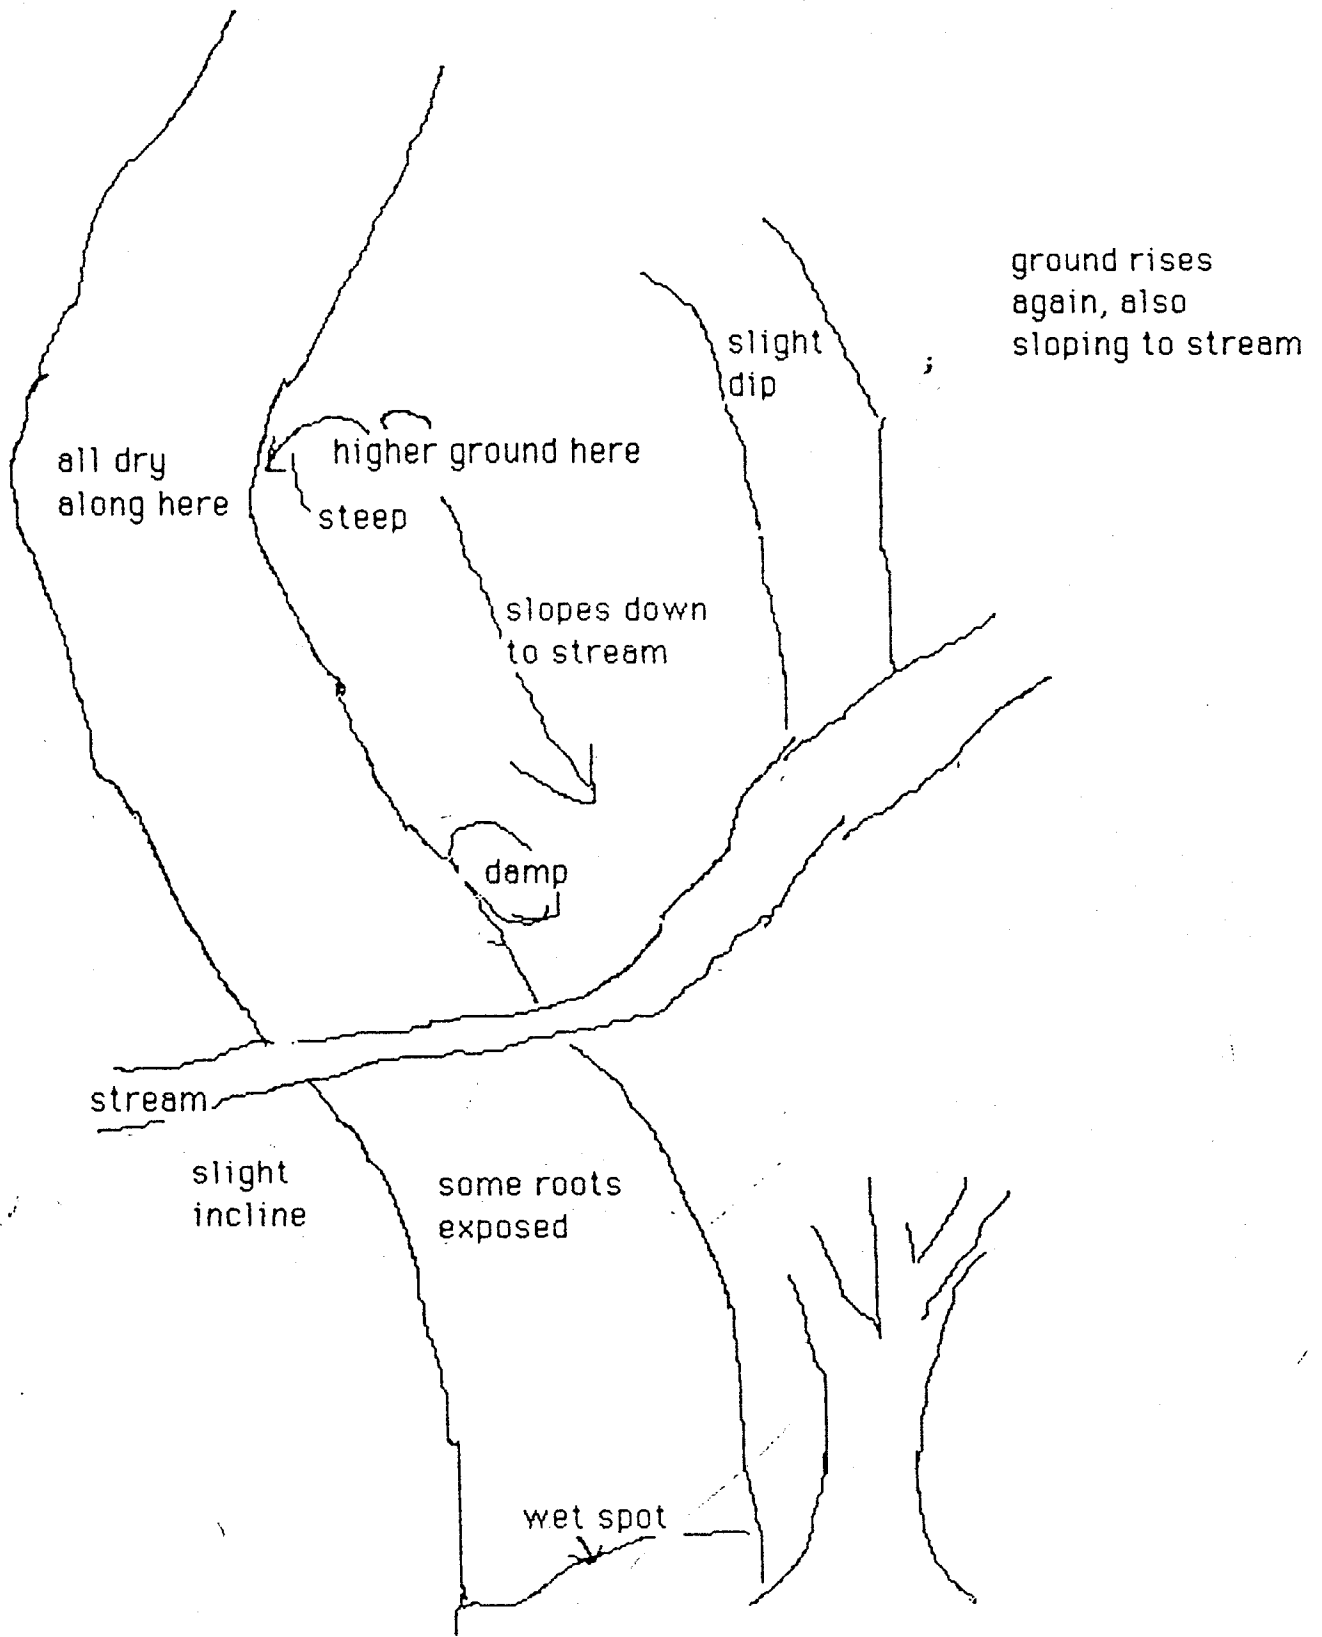
Site 4

SITE 4: As stated in the site 3 description, the trail rises slightly and subsequently dries out. Also in section 4, there are roots exposed which stabilize the trail. Water coming down the hill to this spot would have dynamics toward either the stream or the wet section of trail, because of the high to low gravitational potential. On the opposite side of the stream (time to fill cup 1.1 seconds), the trail is also dry. There is minimal downhill flow of water to this spot because of the topography of the site. To the direct west side of the trail, there is a sharply defined hill, but directly as it reaches its summit-- a few feet vertical distance-- it drops off on the other side. This creates a channel in which water coming down the western hill would collect and dump in the stream. It is also then not a part of any water table. So even though this part of the trail is relatively steep, the land surrounding it puts it in a dry position.

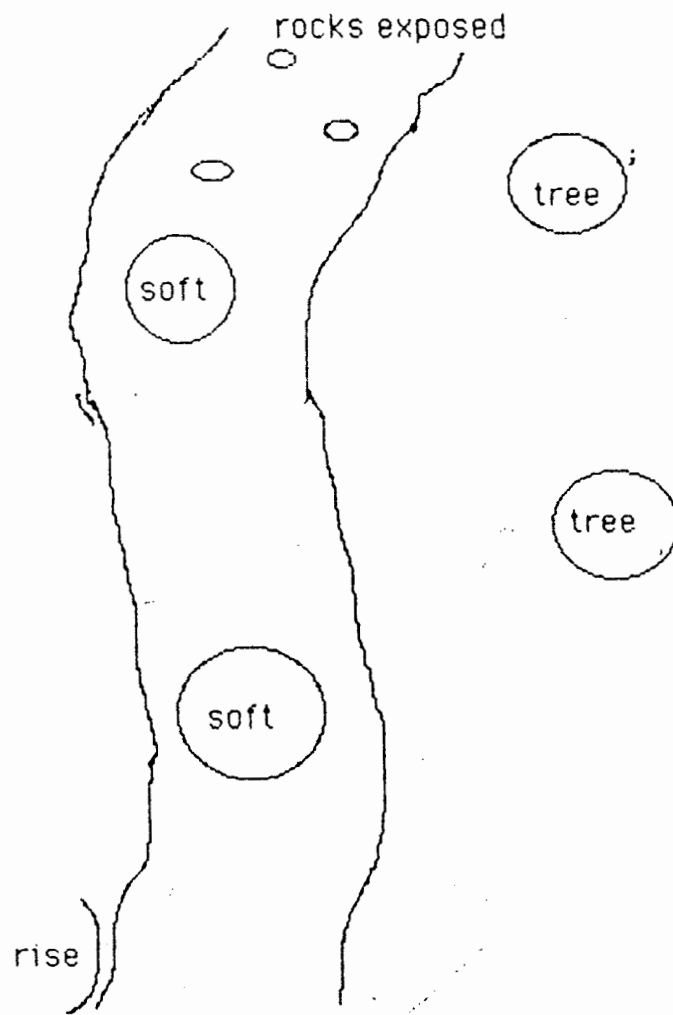
Site 5

SITE 5: This site is also fairly dry. It is probably so because the uphill water would be directed toward the stream still. There are two soft spots. These spots seem to be soft not simply because water is running into them, in which case they might be more toward the uphill side, but because there is a water table somewhere relatively near underneath them, and that is may rise temporarily. There is no real water there, even when the ground is pressed down upon, but is merely a spot where there is some contact with a water source.

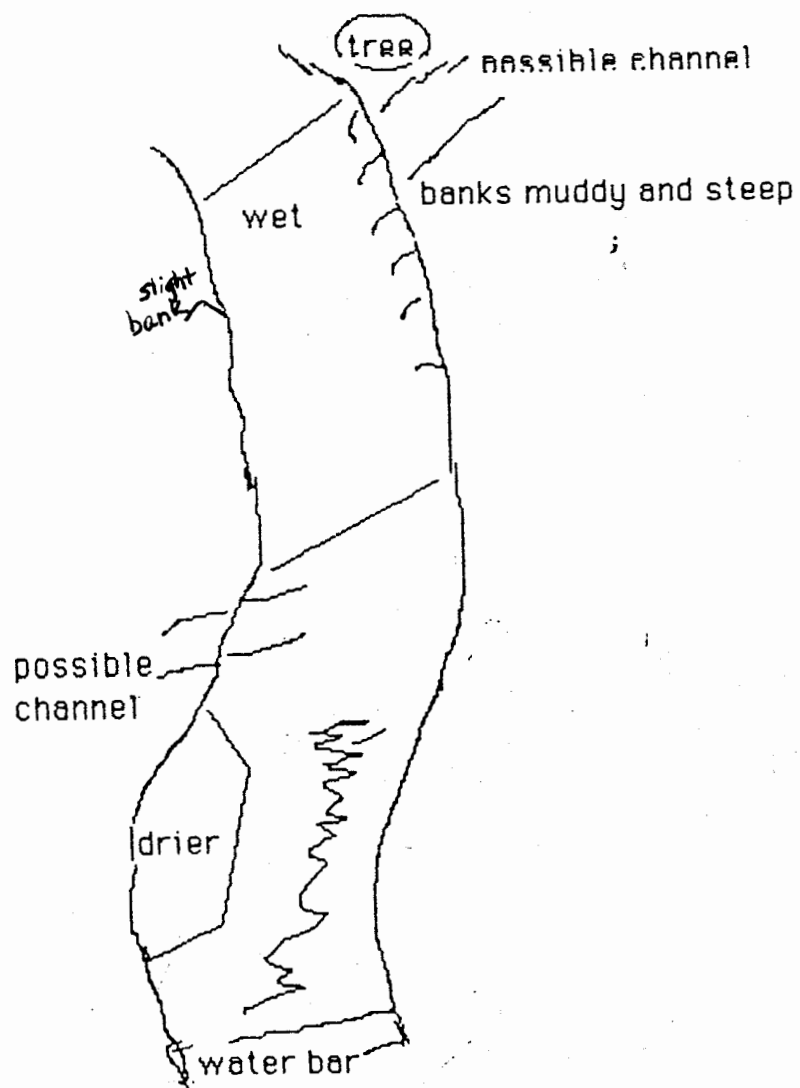
Site 6

SITE 6: Even though there is a water bar at the bottom part of this site, it seems only to become a collection point for water uphill (the hill is very

slight) from it. This is the case in part because the water bar has poor drainage off of the site, so water has nowhere to go. The upper part of this section is extremely wet. Again, the trail has become a collection point for any water coming down the hill (there seems to be a possible channel coming from the uphill side). Because the trail is not at all steep, perhaps less than a percent in slope rise, the water does not immediately run off. So once some of the water from a spring run-off stays, the water in the trail ^(or water snowmelt) becomes a collection point for more water, as described in the introduction. Some of this water might run off the channel drawn on the left side of the page, which is why the lower portion of the trail, which is also steeper, would not have as much permanent water. This characterization is also exemplified by the change the water has done to the ground: in the lower half, it has created a channel which is filled with water because the water bar needs repair, in the upper it has formed a mud basin, since it isn't really attempting to go anywhere.

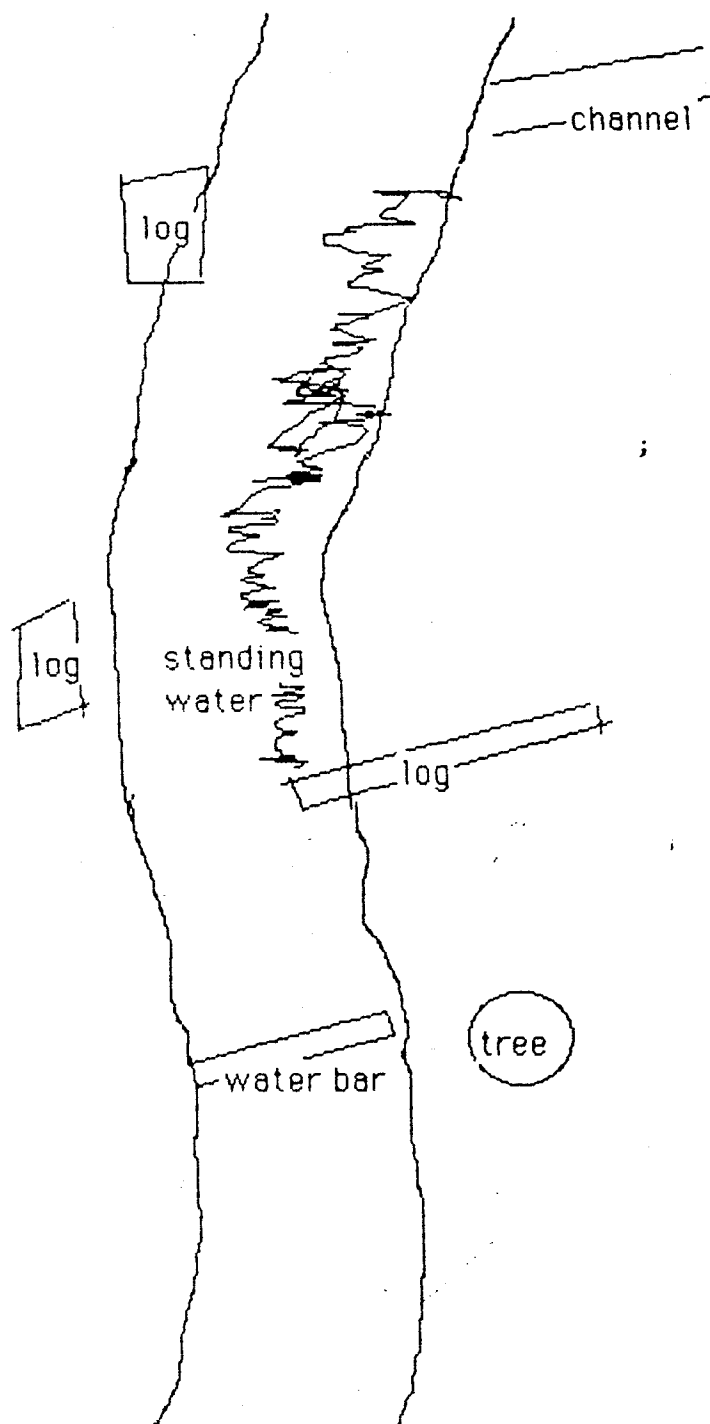
Site 7

Site 7: Water seems to run in here from the channel, as a slight collecting channel from the slope above it. Again, the water stops in the trail because of poor drainage. The down slope bank is slightly higher than the trail itself, and the trail is not very steep, to allow for easy drainage. The water eventually disappears from the trail because the south side of the trail gets lower and the trail steeper, so water falls away more easily. Water could then either run off of the south side of the trail, to one side, or else run directly down, underneath the trail.
