A Walkability Study of North Adams, Massachusetts

Fall 2011

Professor: Sarah Gardener
Client: Mackenzie Greer, BRPC

The following report is a walkability audit of North Adams Massachusetts done on behalf of the Berkshire Regional Planning Commission by Williams College students Clara Noomah, Johanna Eidmann, Emily, Ury, and Alex Long for their Environmental Studies 302: Environmental Planning Workshop class. The study takes an in-depth look at downtown North Adams as well as four proximate residential neighborhoods: Church Street neighborhood, UNO (United Neighborhood Organization), Ashland Street/MCLA (Massachusetts College of Liberal Arts) neighborhood, and State Street neighborhood.

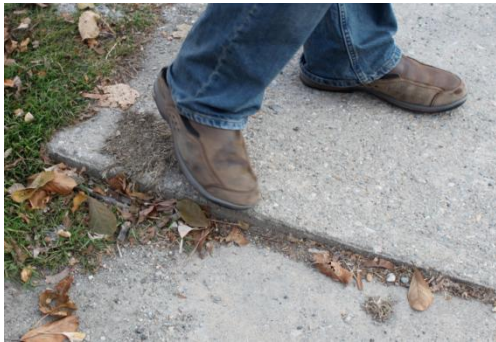
Figure 6: Church Street Sidewalk

Since discontinuous sidewalks or sidewalks with cracks and bumps, like the one seen in Figure 6, can make walking difficult for people with strollers or walking aids, such sidewalks received lower ratings. Furthermore, an extremely narrow sidewalk or one that has been blocked

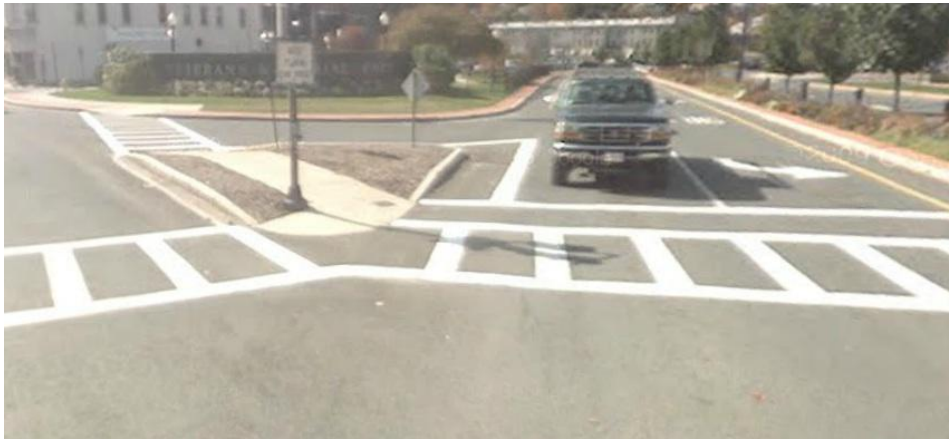
Figure 7: Intersection at Eagle Street and Mohawk Trail (Google Maps Streetview)

Because crosswalks are areas where pedestrians come into close proximity to vehicular traffic, they are some of the most hazardous locations for pedestrians (see Figure 7). Good crosswalks are visible to drivers and make pedestrians feel like they have the right of way. To ensure this, crosswalks should be placed in frequent and useful locations (efficacy) and have clear signage for cars, smooth curb cuts and visible on-road indication. A major portion of our evaluation of walkability is identifying places where crosswalks are needed but do not yet exist.

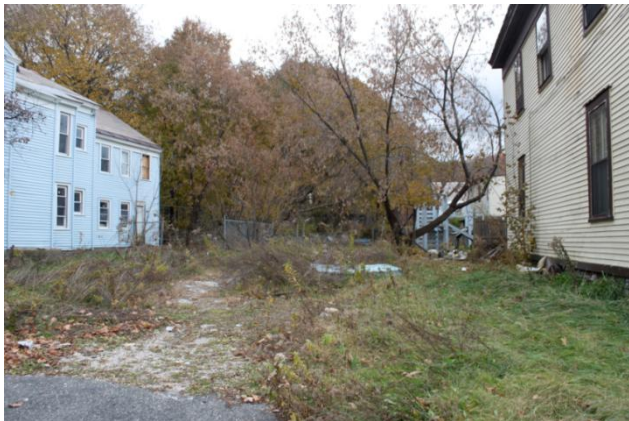
Figure 9: Abandoned house and empty lot on Spring Street

Safety is an important component of any pedestrian environment. There are various different factors that influence a person's safety while walking. Safety from vehicles is a main concern (addressed in the Crosswalk and Sidewalk section of our audit), but so is personal safety, achieved in areas of low crime and the presence of other pedestrians. This section of the evaluation looks specifically at nighttime lighting, appropriate traffic speed and an overall feeling of safety. A pedestrian on a safe street should not feel as though the cars are too close or moving too fast. They should furthermore neither feel harassed nor isolated as they walk down a street. Abandoned and dilapidated houses, empty lots, aggressive dogs, broken glass and litter detract from the feeling of safety score (Figure 9).

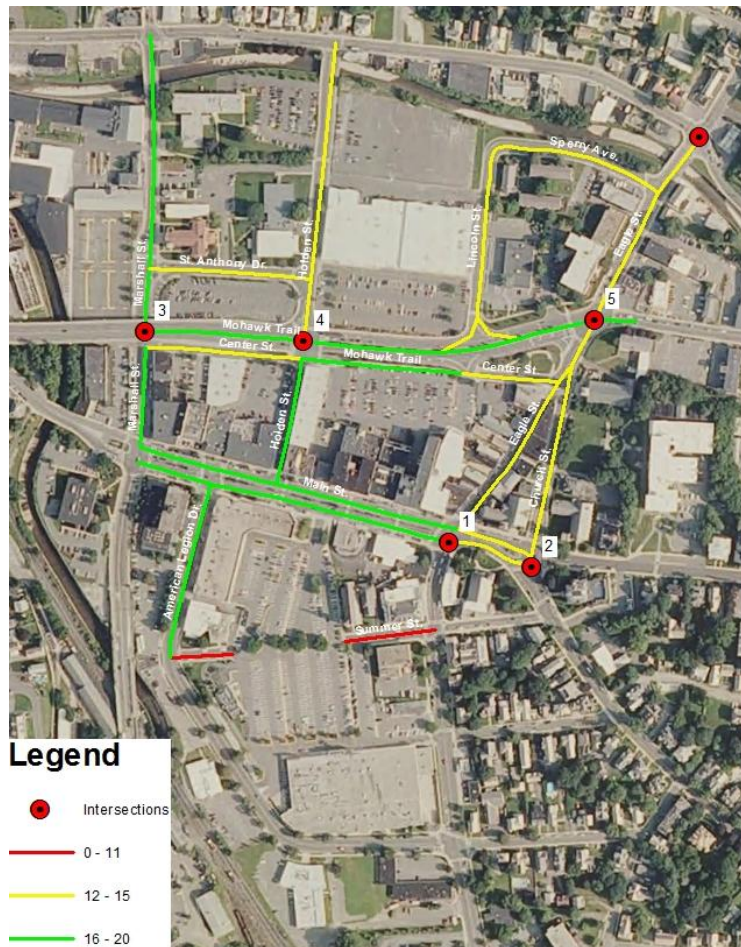
Figure 11: Downtown crosswalk score and key problematic intersections.

Downtown North Adams received high scores for overall walkability. In general the sidewalks are in good condition (Figure 10), benches, trees and other amenities are present, and store fronts are largely inviting. A map of our evaluation of the downtown (see Appendix G6) shows that almost every street received a green rating (total scores between 51 and 80 out of 80 that reflect an average of 4-5 out of 5 for individual criterion) for their overall score. The only street not to achieve such a high score was Summer Street, which is interrupted by a large parking lot that is largely unsafe for pedestrians. Although many segments had an overall score, we should also note the need for improvements on crosswalks in the area, especially at key intersections (Figure 11).

There are many specific intersections that need to be addressed, where we observed people jaywalking due to absent or inadequate crosswalks (refer to Figure 11 for specific problematic intersection locations). One intersection that we believe should be a high priority for pedestrian safety is the intersection of Rt. 2 and Eagle St (identified as number 5 in Figure 11). This is a wide intersection and the streets do not cross perpendicularly, which makes it difficult for pedestrians to see incoming traffic. Crossing this intersection also physically takes much longer than the signal allows for, thereby increasing the amount of jaywalking that occurs at the intersection. We would therefore propose a diagonal crosswalk across the intersection that would require cars traveling in both directions to stop at the same time. This would allow pedestrians to cross towards any side of the street in one signal, thereby reducing the incidence of jaywalking.

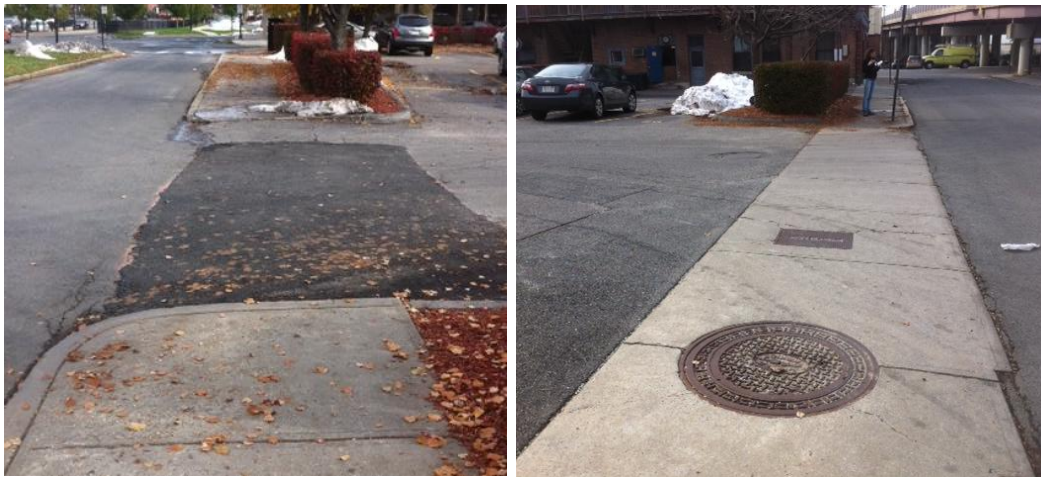
safety. Driveways can often be dangerous places for pedestrians, and while most sidewalks tend to be continuous across driveways, there are several instances in the downtown where driveways are actually paved over crosswalks (Figure 13). This gives the priority to the driver and is one thing that could be addressed in the downtown to make it more pedestrian-friendly.

Figure 13: Examples of driveways (found on Center Street) that favor the car and the recommended driveways that have a continuous sidewalk and favor the pedestrian.

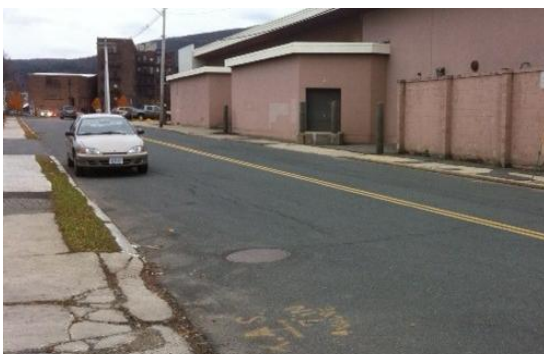
Figure 14: Sperry Avenue behind Big Y

Lastly, there are a few places in the downtown where disrepair and damage negatively affects the walkability of the street. Under the Rt. 2 overpass of Marshal Street near Mass MoCA, for example, dark parking lots and few crosswalks give this area a negative and unsafe atmosphere. Another location that could use improvements is behind the Big Y Supermarket on Sperry St. (Figure 14). The decrepit store back, rusty fence, vacant parking lot and crumbling

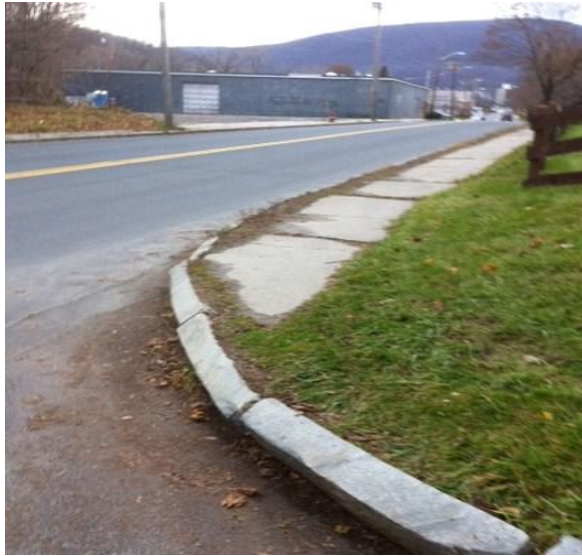
intersection of Davenport and Ashland. Where the sidewalk should wrap around the northeast corner, it stops and turns into a patch of grass (Figure 15).

Figure 15: The photo below was taken standing at the corner of the above picture, looking south down Ashland street. The sidewalk abruptly ends and the road narrows and goes under an overpass, making almost impossible for pedestrians to continue walking safely.

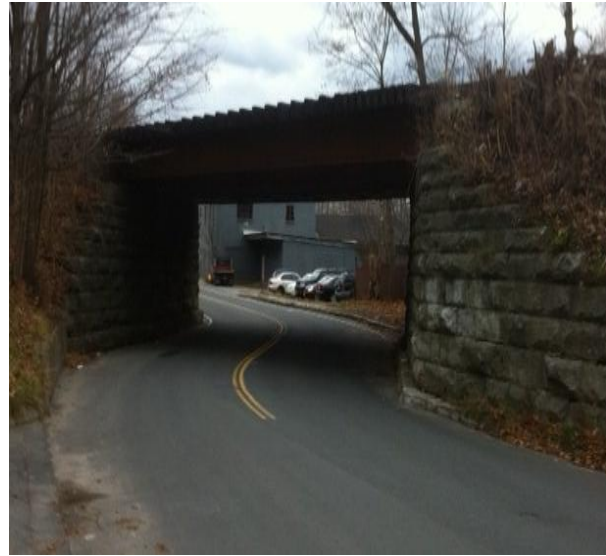
Figure 16: End of sidewalk at Davenport Street and Ashland Street

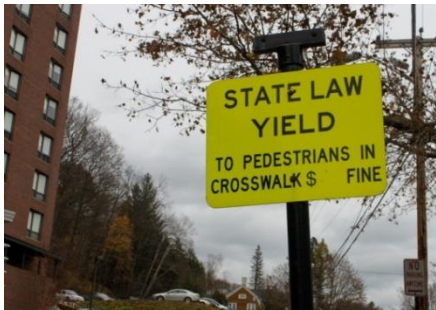
the crosswalk across Church Street in front of Berkshire Towers is used frequently. Church Street is one of the busiest streets in North Adams and cars on the street tend to drive at higher speeds than they do in other parts of the Ashland/MCLA neighborhood. Along the side of the

Figure 17: A neon sign warning drivers of crosswalk near the Berkshire Towers.

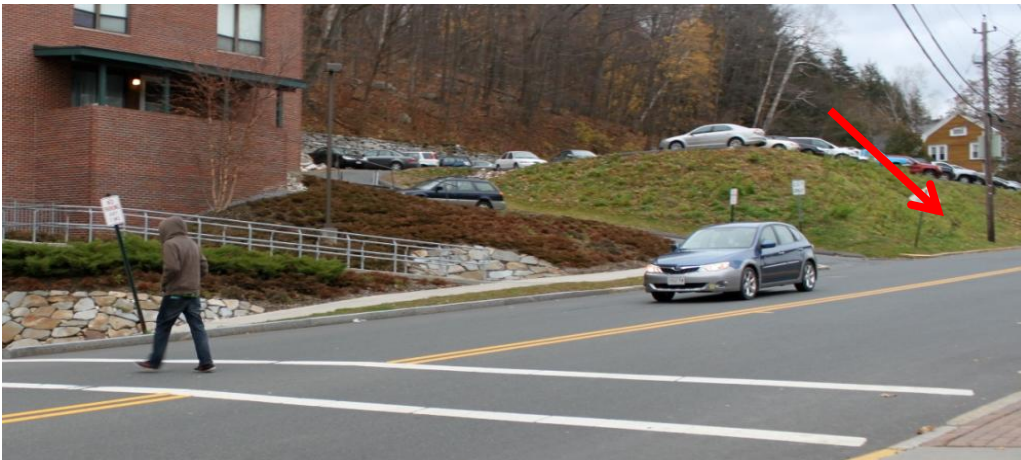
street to the west side of the street or walk up a steep hill and walk through a parking lot. Even after passing the parking lot, there is no sidewalk on the east side of the street. Because Church Street is one of the busier streets in the city and cars tend to drive quickly, pedestrians would need to cross the street again to stay on a sidewalk. The inconsistency of sidewalk on Church Street isolates the streets and house that lie east of the Ashland neighborhood and reduces the connectivity between Ashland and eastern areas, including Windsor Lake.

Figure 18: The red arrow points to where the sidewalk abruptly (Church St).

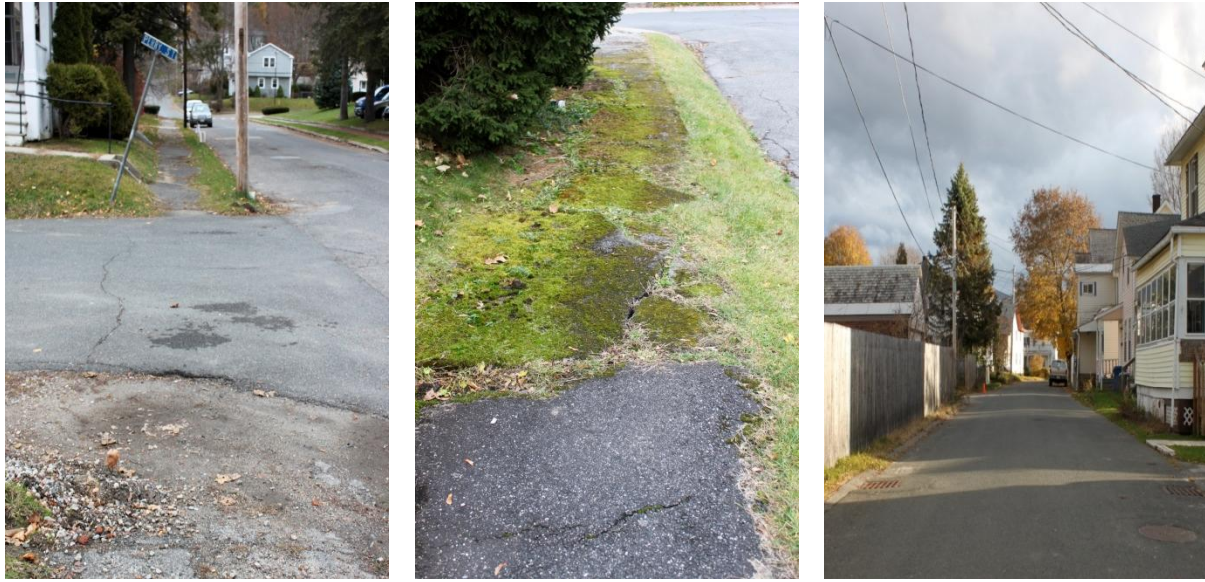
Figure 19: Images of deteriorating, overgrown, or nonexistent sidewalk on Elmwood, Willow, and Royal Streets

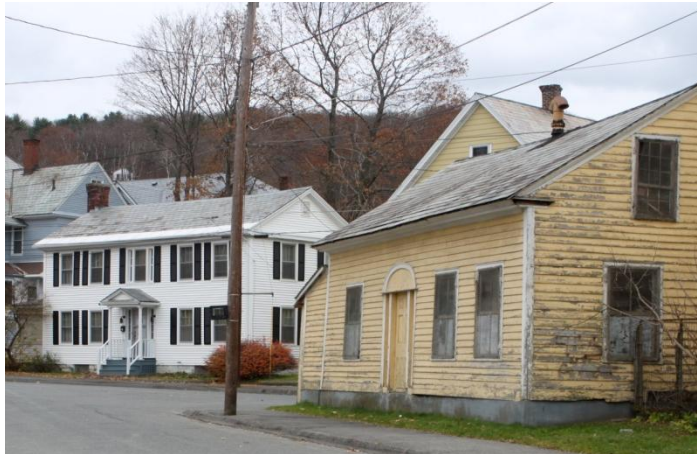
difficult for pedestrians to continue from Washington Avenue to South Street. Furthermore, since there is a building at the corner of the convergence, it is difficult for cars to see pedestrians crossing the street (Figure 20). Because of this, we propose adding a crosswalk across Washington Avenue and State Street at their convergence to increase pedestrian safety.

Figure 20: Awkward triangulation between South Street and Washington Avenue—the yellow building pictured limits the possibility for drivers to see pedestrians. There are also no crosswalks at this intersection.

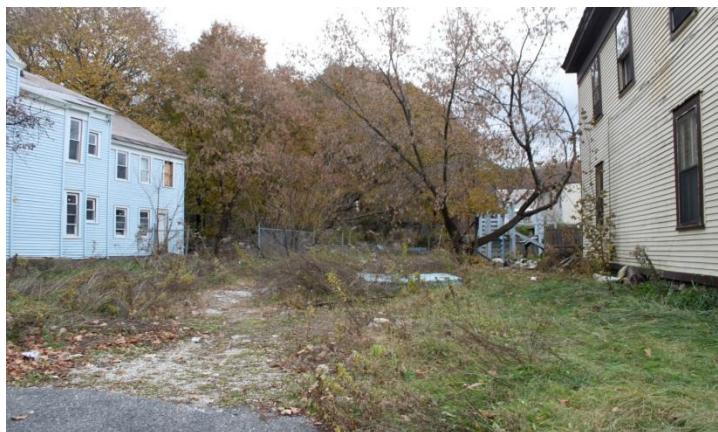
Finally, there were some areas in Church Neighborhood that felt unsafe. For example, on Spring Street, between Chestnut and Church Street, there was an area that was characterized by abandoned, boarded up houses and abandoned lots (Figure 21). Broken glass littered the sidewalk and lighting was poor, making the segment feel unsafe.

Figure 21: An abandoned lot with dilapidated house and playground on Spring Street.

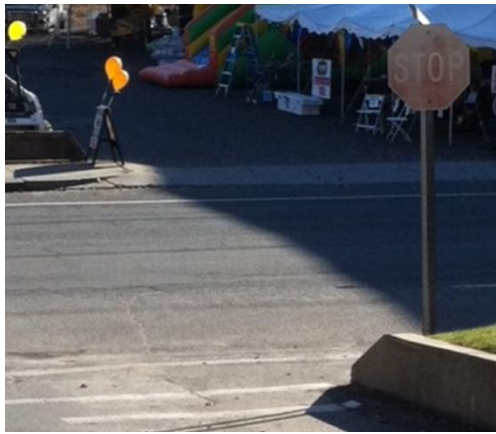
Figure 22: Intersection of Hooker St. and State St., showing faded crosswalks and signs.

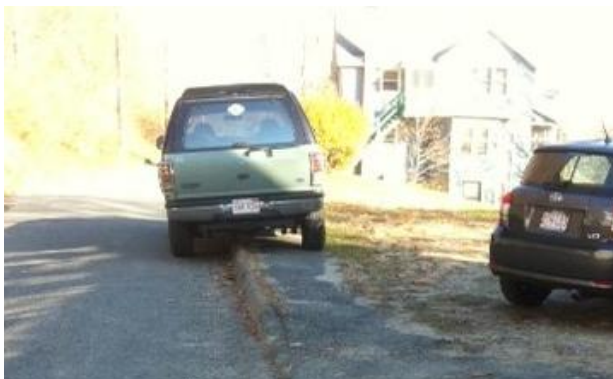
Many of the residential side streets of the State Street neighborhood were narrow and filled with cars. However, because there is not enough space to park on the streets, many cars parked on the sidewalk (Figure 23). Such behavior makes the sidewalk discontinuous and inaccessible to the pedestrian, forcing them to walk on the street. Parked cars also create blind spots and, when combined, these two effects can make walking unsafe. Furthermore, by habitually parking on the sidewalk, many cars have caused a rapid deterioration of the sidewalk conditions and the curbs. Although we acknowledge that many of the streets are narrow, we

Figure 23: A picture portraying cars parked on the sidewalk, impacting the condition of the sidewalk and making it discontinuous.

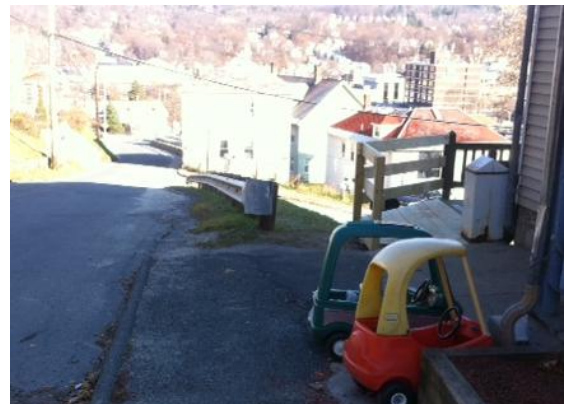
Our assessments of this neighborhood uncovered a number of specific areas that could be improved significantly increase the walkability of the neighborhood (Table 8). One of the basic components that has a tremendous impact on the quality and safety of a walk is the continuity of a sidewalk. Furnace Street, however, is one street that does not have such a continuous sidewalk. Instead, the sidewalk ends abruptly; leaving about 50 meters without a sidewalk, and begins again on the other side of the street. As evidenced by the toys in Figure 24, families with small children live in this section. Such a sudden ending of the sidewalk can therefore drastically increase the danger of this segment to pedestrians, especially small children.

Figure 24: A picture showing the segment on Furnace Street where the sidewalk abruptly ends.

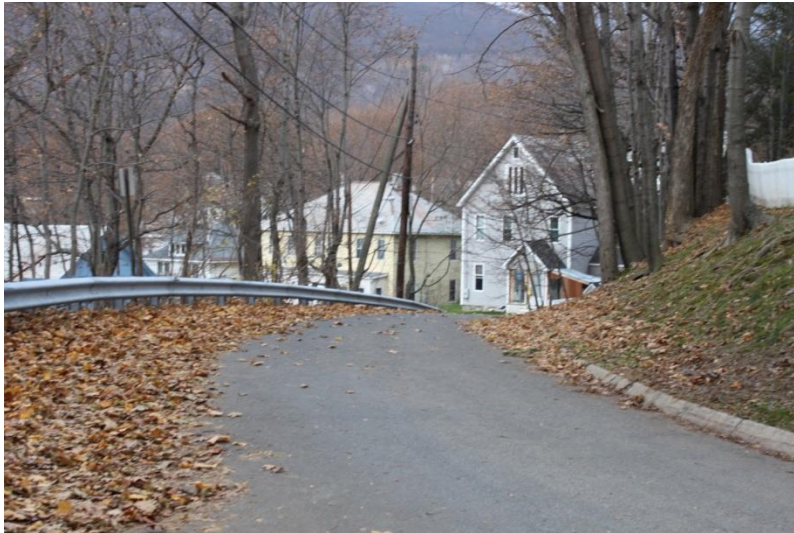
Figure 26: Chase Hill Road, no sidewalk on either side.

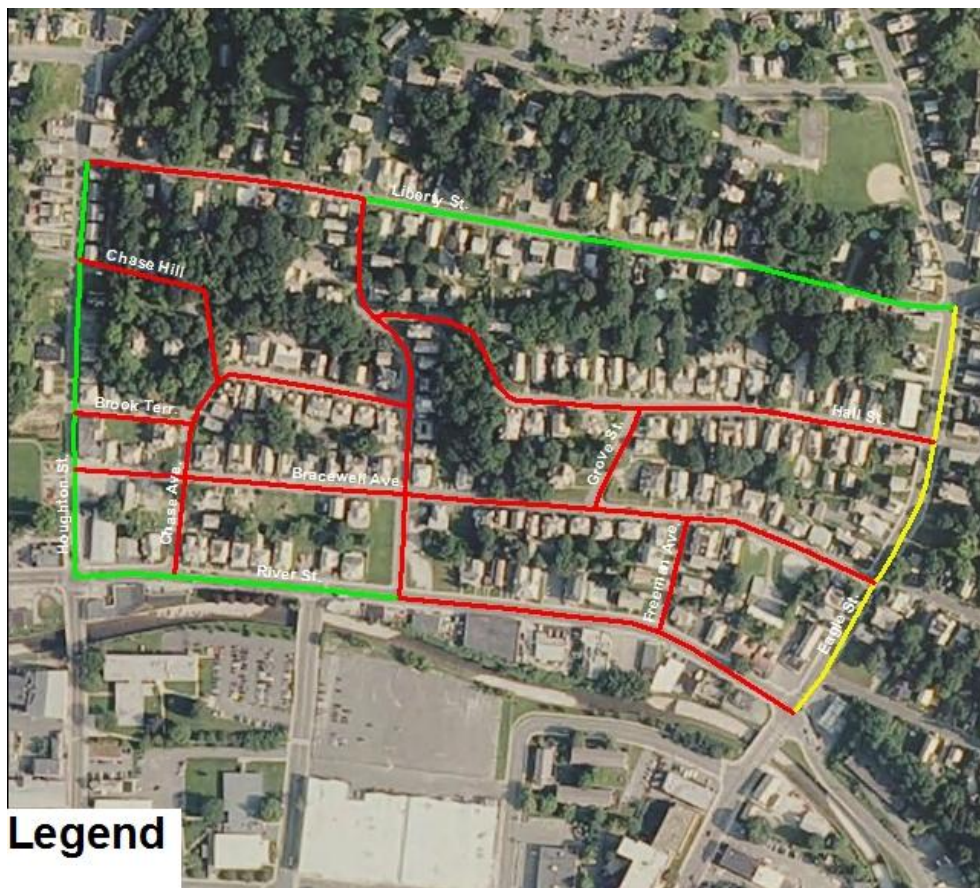
Figure 27: UNO Neighborhood Crosswalk Scores

As shown in Table 9, one of the most frequent general recommendations for this neighborhood is the addition of crosswalks. Figure 27 below, which compares the scores of crosswalks in this neighborhood, shows just how poorly this neighborhood ranked in this category:

Simple on-road indications could be added at almost every intersection in the UNO neighborhood. There are also many intersections with faded or missing stop signs. Special attention should be given to the crosswalks near the park on Houghton St., (Figure 28) where children frequently cross. Additional signage would be effective for increasing safety.

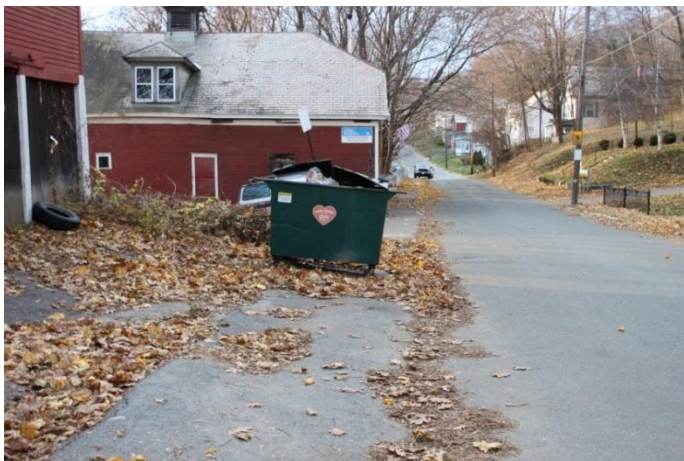
Another common issue is the obstruction of the sidewalks by cars, garbage cans, and other debris, an example of which can be seen in Figure 29. Because of the narrow streets, cars frequently park on the sidewalk, which can be unsafe for pedestrians. Effort could be made to ensure adequate parking in driveways for residents. Additionally, more attention to the general upkeep and maintenance of the streets and sidewalks in this neighborhood would make this neighborhood a more pleasant place to walk.

Figure 29: Leaf Litter and Dumpster Obstructing the Sidewalk in UNO Neighborhood
