Christmas Brook: Naughty or Nice?

An Evaluation of Local Water Quality

By Becky Davies, Sam Denton-Schneider and Ben Swimm

ENVI 102, Professor Dethier

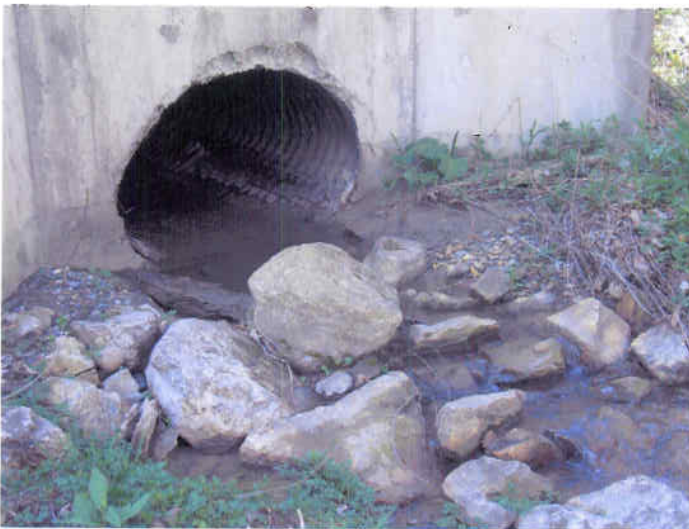
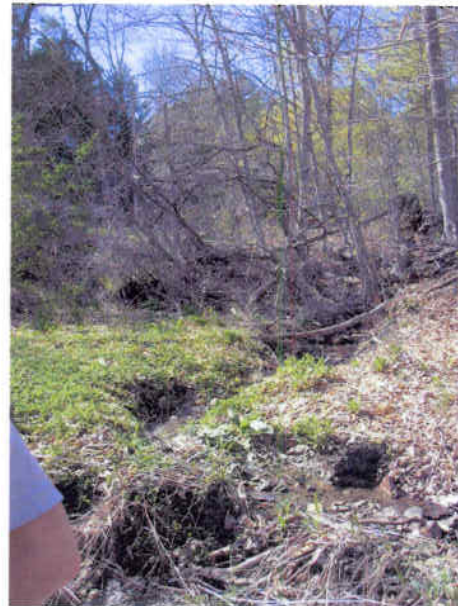
Figures 1 & 2: Phoebe's Brook as it passes from under Gale Road (Left) and the West Branch of Christmas Brook before it merges with Phoebe's Brook (Right)

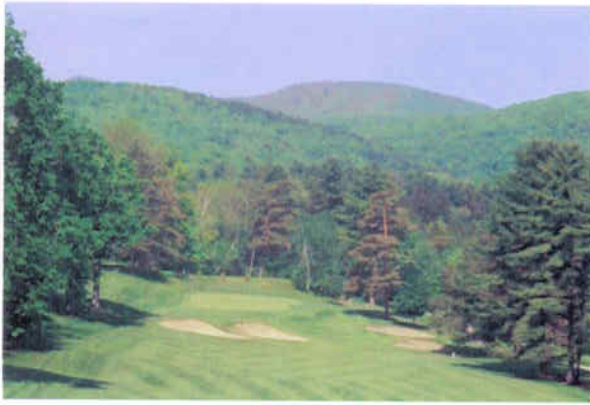
First opened in 1896, the golf course has had ample time to alter the surrounding environment ("Taconic"). Visibly, the golf course's manicured greens compromise the natural wetlands that they cover (Appendix 7).

Figure 3: The Taconic Golf Course
<http://www.golfclubatlas.com/taconic1.html>

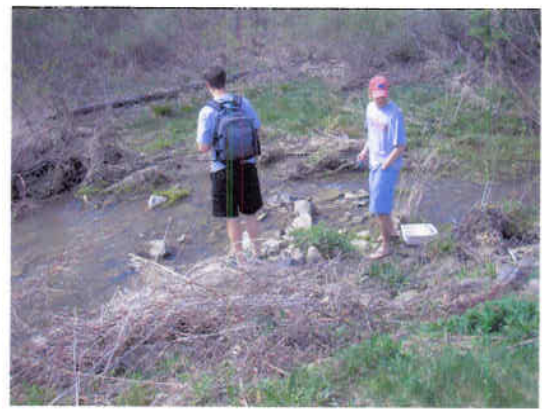
Figure 4: Christmas Brook at the 18th Hole

The resulting loss of organic matter and aquatic life could alter stream water chemistry and the stream's ability to absorb inputs. Though less immediately apparent, the effects of fertilizers and chemicals used to treat the golf course also threaten Christmas Brook, which receives the runoff from applied substances. In the spring and fall, the golf course receives ammonium sulfate based fertilizer, in addition to a slow-release potassium bulk spread applied in late June. Every three weeks the course receives soluble urea nitrogen. Annually, the course receives 2.5 lbs of potassium and nitrogen per square foot from fertilizer, plus trace amounts of phosphorous. In the past, the golf club used a natural organic fertilizer, but found that it easily ran off, burdening the brook and requiring additional fertilizer. Maintenance also requires preventative fungicides applied in rotation so as to prevent plant resistance. The fungicides include Dacono, Banner Maxx, Chipco 26GT, Touche, Subdue Maxx and Bayleton. Groundskeepers apply insecticides such as Merit and Scimitar once a year when necessary, but have not done so this year. Lastly, the golf course receives spot treatments of herbicide, in concentrations as low as five to six ounces for 10 to 15 acres of treatment (Lemme). Planned additions of 200 yards of golfing greens this winter will eliminate nearby plant life and trees, and potentially increase runoff into Christmas Brook, furthering affecting stream health.

sampled. While in the pond, it is likely that the water collects runoff from the golf course, including the fertilizer. Our poor biotic index value for the 18th hole site was supported by data showing the 18th hole to have high levels of conductivity (Figure 17). The stagnant water could also provide a good habitat for certain species of invertebrates which usually indicate poor water quality. Also, it is important to keep in mind that while diptera are extremely tolerant to pollution, that does not necessarily mean that they are only found in polluted water.

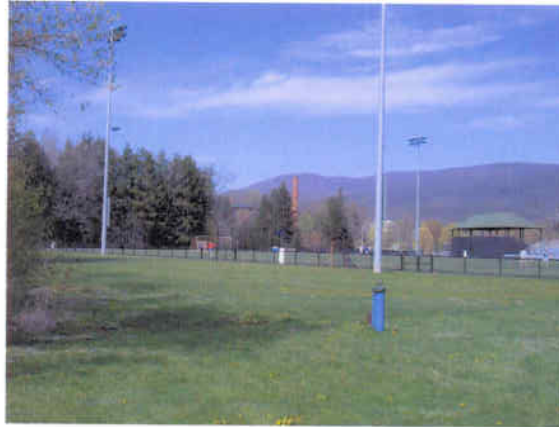
Figure 5: Lamb Field, a turf field constructed in 2004

The removal of a baseball diamond in close proximity to the stream (map) potentially reduces chemical inputs to Christmas Brook, since the new turf field in its place requires no chemical maintenance. However, the stream still borders a parking lot and resides near a football field that receives 1250 lbs of fertilizer—containing vast amounts of nitrogen—in the late fall, polymer coated slow-release fertilizer in the spring, and fungicides in the summer, including Chipco GT, Bayleton, and Subdue Maxx (Fitzgerald). Runoff or groundwater saturation can drain these chemicals from the fields into Christmas Brook. Aside from field applications, human activity at the site results in the accumulation of inorganic waste such as plastic bags and broken bottles in Christmas Brook.

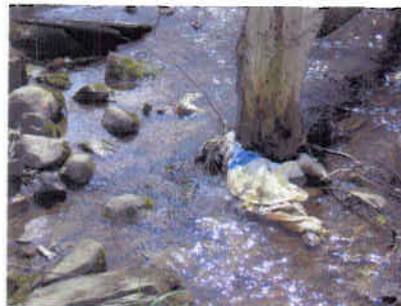
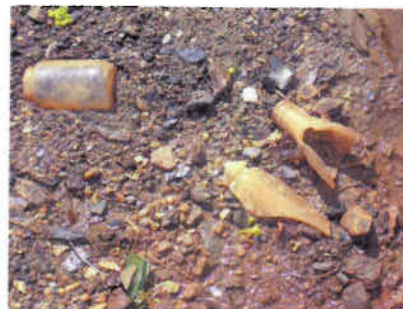
Figures 6 & 7: Christmas Brook pollution is evidence of human activity at the Weston Athletic Field Complex

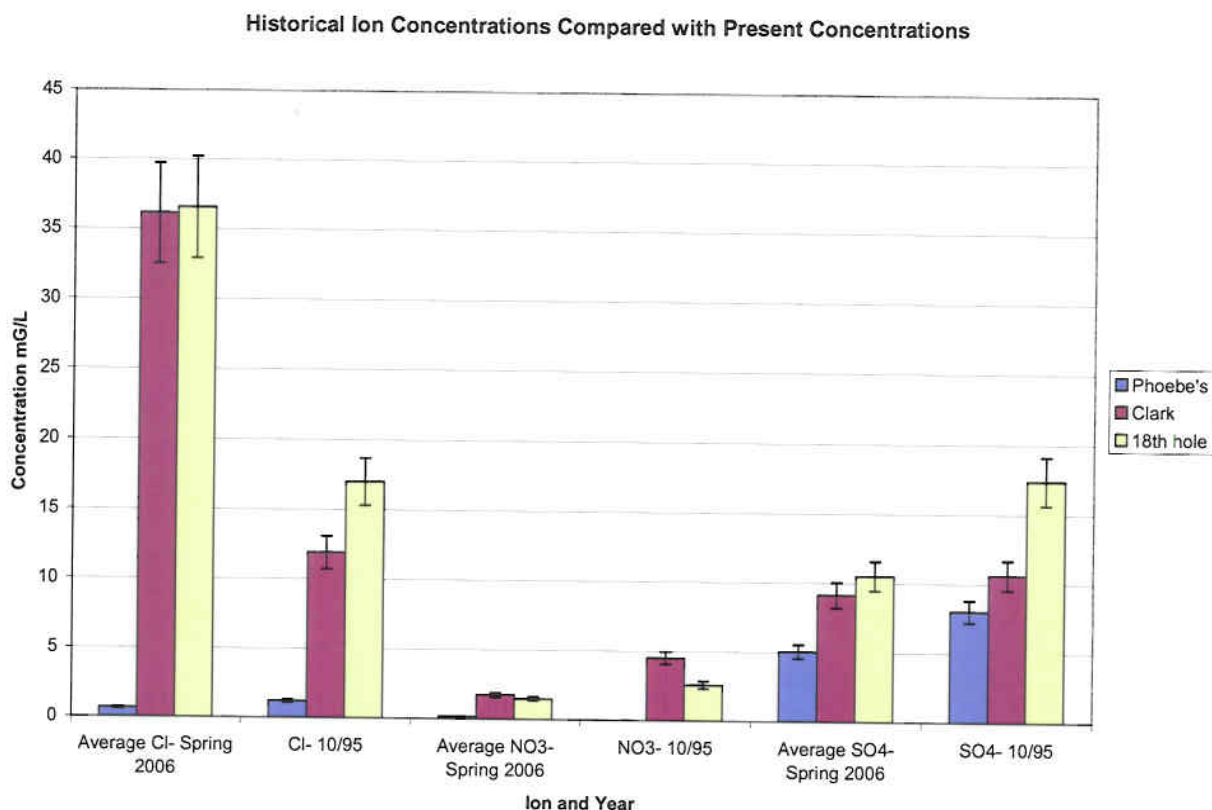
Figure 9

Ion chromatography tests also exhibited decreases in sulfate and nitrate since 1995. In 1995, nitrate concentrations were 0mg/L at Phoebe's Brook, 4.53 mg/L at the Clark sampling site, and 2.59 mg/L at the 18th hole, while in 2006 concentrations fell to 0.16, 1.73, and 1.49 mg/L, respectively. Similarly, concentrations of sulfate dropped by 3.0mg/L at Phoebe's Brook, 1.46mg/L at Clark, 6.9mg/L at the 18th hole since 1995. An opposite trend, however, appeared in the relationship between historical and present levels of chloride. While chloride levels at Phoebe's, Clark, and 18th hole were 1.2, 11.9, and 17.0 mg/L in 1995, they averaged 0.66, 36.1, and 36.6 mg/L in 2006 (Figure 9).

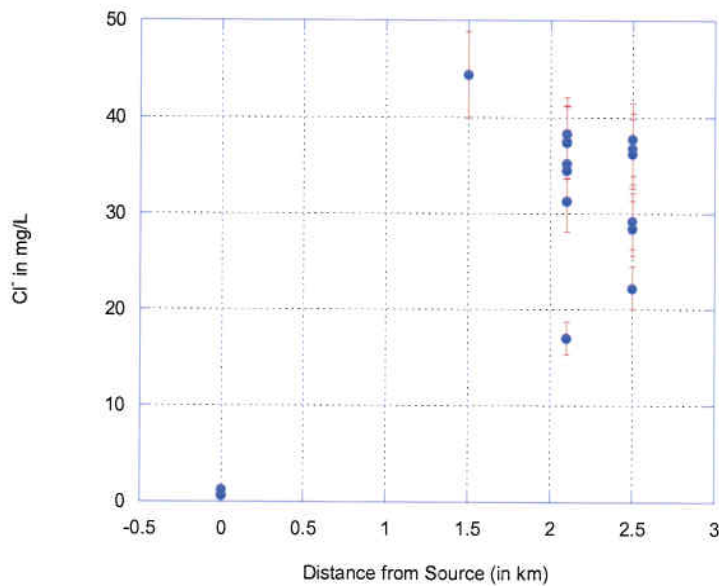
Figure 10

Assuming that the chloride levels found at the Phoebe's Brook site represent background levels, we can evaluate the current health of the watershed. According to these values of under 1 mg/L, all other tested sites indicated human impact in the form of some input of chloride into the watershed. Levels of chloride at each sampling site correspond to the distance of the site from the headwaters of Phoebe's Brook, with concentrations rising further from the headwaters where contamination can arise from roads, residential areas, and the golf course (Figure 10).

Concentration of Chloride Ions as Christmas Brook Progresses Further from the Original Water Source

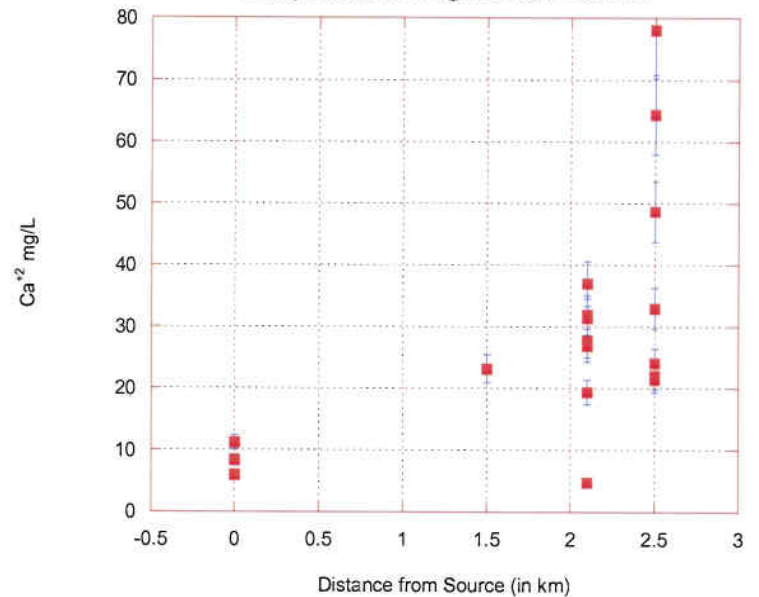
Figure 11

Other ions echo this trend. For example, as Phoebe's Brook progresses further from the original source, levels of sodium and calcium increase precipitously. Calcium concentrations, rise from 8 mg/L in Phoebe's Brook water source to over 20 mg/L in the golf course, 1.5 km away, and as high 50-80 mg/L at Latham St (Figure 11). Sodium ions concentrations also

Concentration of Ca⁺² Ions As Christmas Brook Progress Away From the Original Water Source

Calcium ions also increase drastically as the stream progresses away from its original water source (Figure 11). This was unexpected, and could be due to a variety of factors. First, the area of Stone Hill upon which Phoebe's Brook originates is geologically composed of mostly quartzite, a mineral which weathers very slowly and would deposit only small amounts of calcium into the stream. Downstream, however, Christmas Brook crosses areas of marble, which

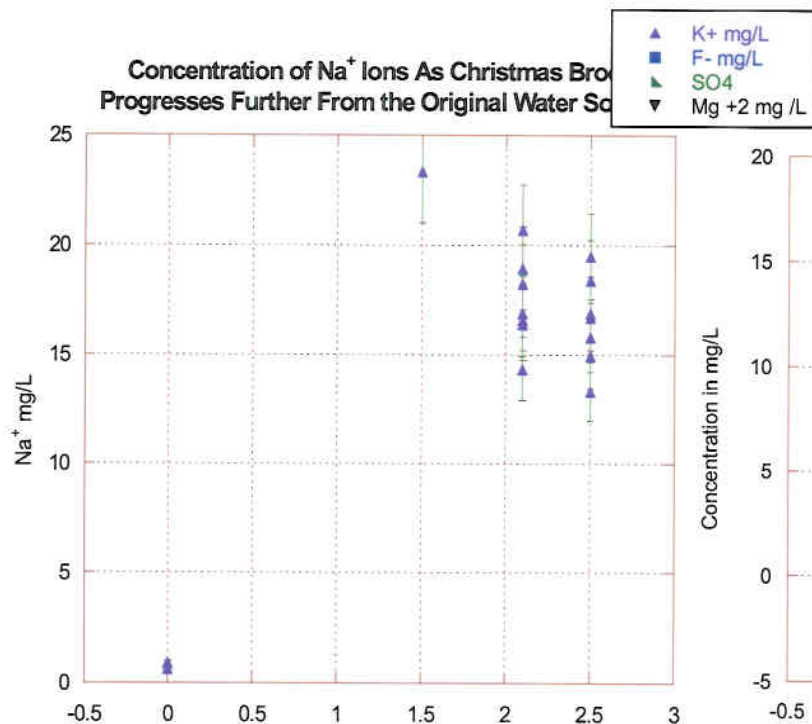
Figure 12

increase dramatically downstream. At Phoebe's Brook the average concentration of sodium is 0.4 mg/L, while the concentration of sodium is 23 mg/L in the golf course and about 16 mg/L at Latham Street (Figure 12).

Concentration of Na⁺ Ions As Christmas Brook Progresses Further From the Original Water Source

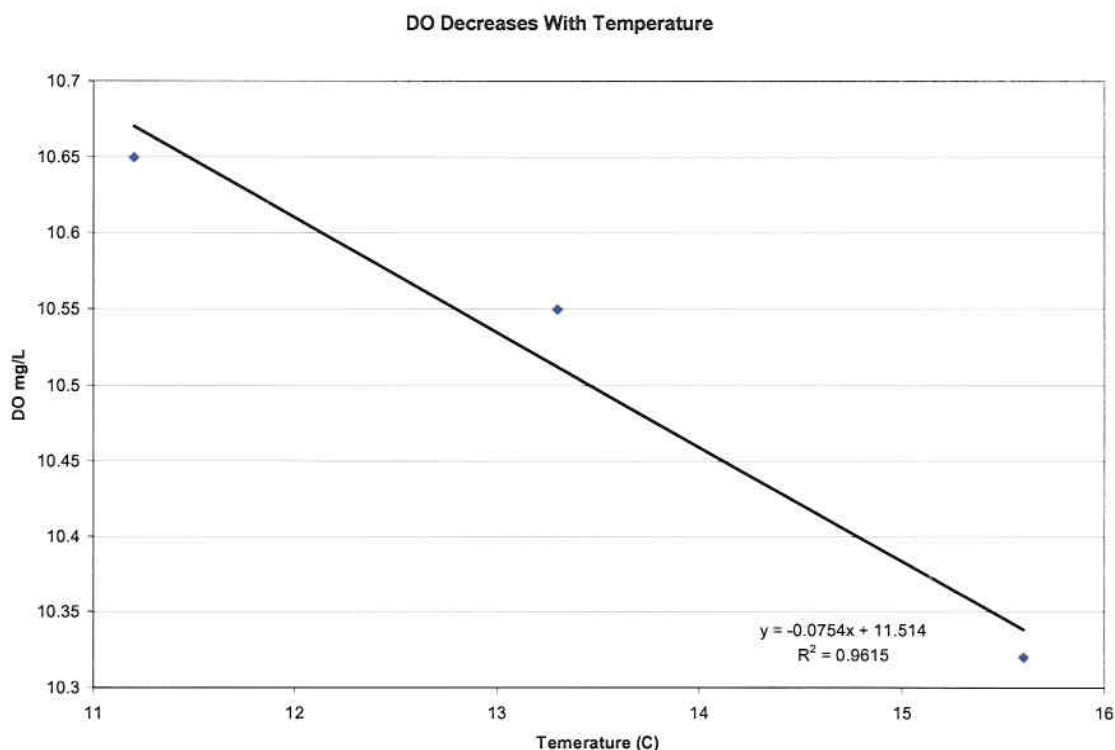
Figure 20

As the temperature at each site decreased, we observed a trend of higher dissolved oxygen. The R-squared value of .9615 indicates the close correlation between DO and temperature (Figure 20).

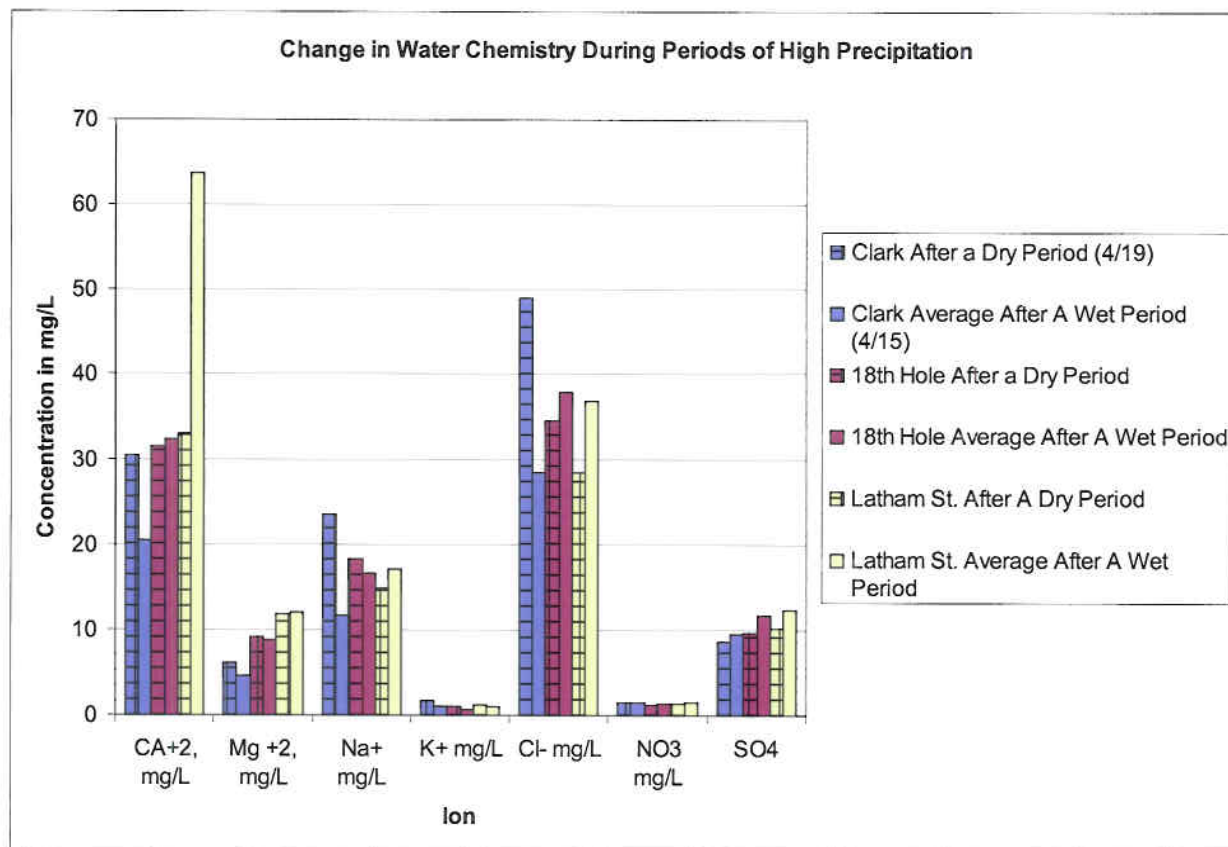
Figure 24

Ion concentrations tended to decrease after rainfall upstream, but increased after rainfall at the 18th hole and Latham sites (Figure 24).

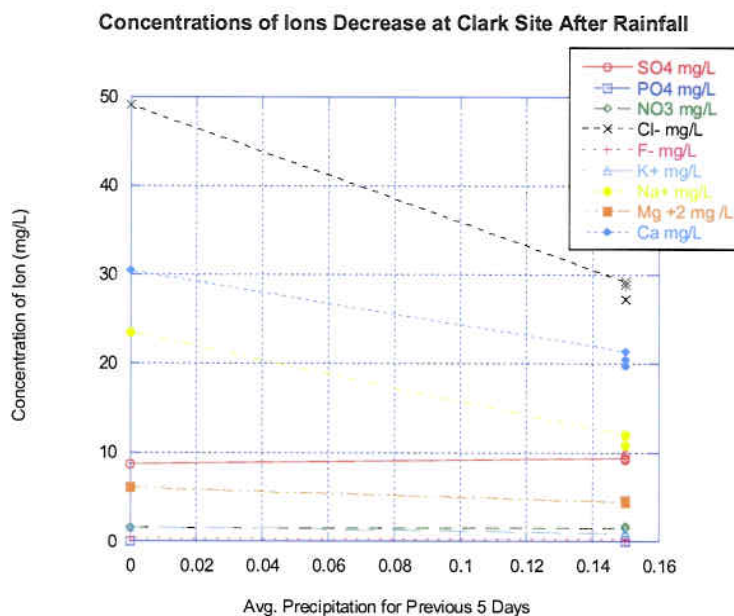
Figure 25

At the Clark, the furthest upstream site tested after precipitation, chloride, calcium, and sodium concentrations dropped dramatically with increasing levels of precipitation, while the concentration of other ions remained approximately constant (Figure 25).

The reduction in ion concentrations after rainfall at the Clark sampling site may be due to the isolated nature of the site. Of all the sites sampled after precipitation, it is the most removed from human contact and the furthest upstream (Appendix 4). This means it is least affected by humans and suffers from fewer anthropogenic input sources. Many of its inputs are likely related to native animals, such as fecal contamination, that may be deterred from entering the

river in periods of high rainfall. Thus, the rain may reduce inputs into the stream while diluting it, lowering ion concentrations. This trend was most evident in the large decreases in chloride, calcium, and sodium concentrations. We can attribute this to the fact that chloride, sodium, and calcium are mostly human inputs that come from road salt and water softener, most significantly calcium chloride. Since the Clark site is generally removed from human contact compared to the other sites sampled for ion concentration before and after precipitation, we would expect the concentration of the ions to decrease after rainfall because of the lack of human inputs washed into the brook, and the cleansing effects of the rain water pushing ions downstream. Thus, dilution of the brook has a large affect on decreasing the concentration of ions.

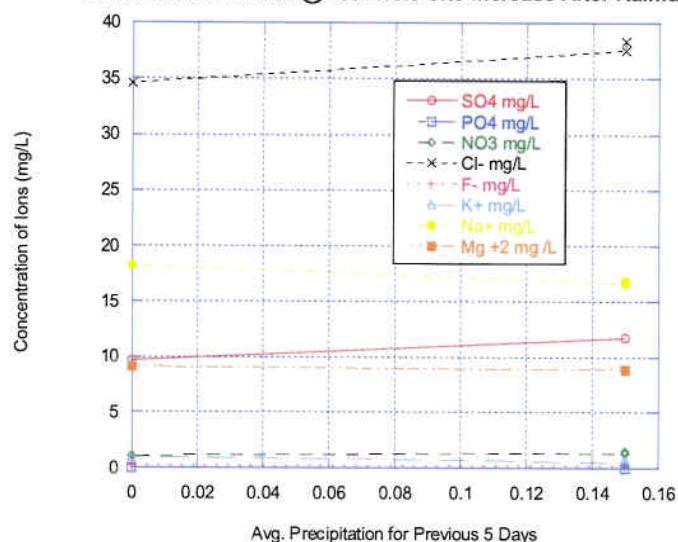
Figure 26

Concentration of Ions @ 18th Hole Site Increase After Rainfall

At the 18th hole, the concentration of every ion except sodium stayed constant or increased after precipitation (Figure 26). Most notably, the concentrations of chloride and sulfate increased while the concentration of sodium marginally decreased.

The increase in the concentration of most ions at the 18th hole is telling. Although the sodium concentration decreased slightly, it may have decreased because of dilution from precipitation. The increase in sulfate may be due to the fact that an ammonium sulfate fertilizer is applied to the golf course in the spring, and the rain may have washed fertilizer into the brook. Increased runoff could also explain the rise in chloride from various undetermined sources, possibly golf course chemicals, or city water system leakages.

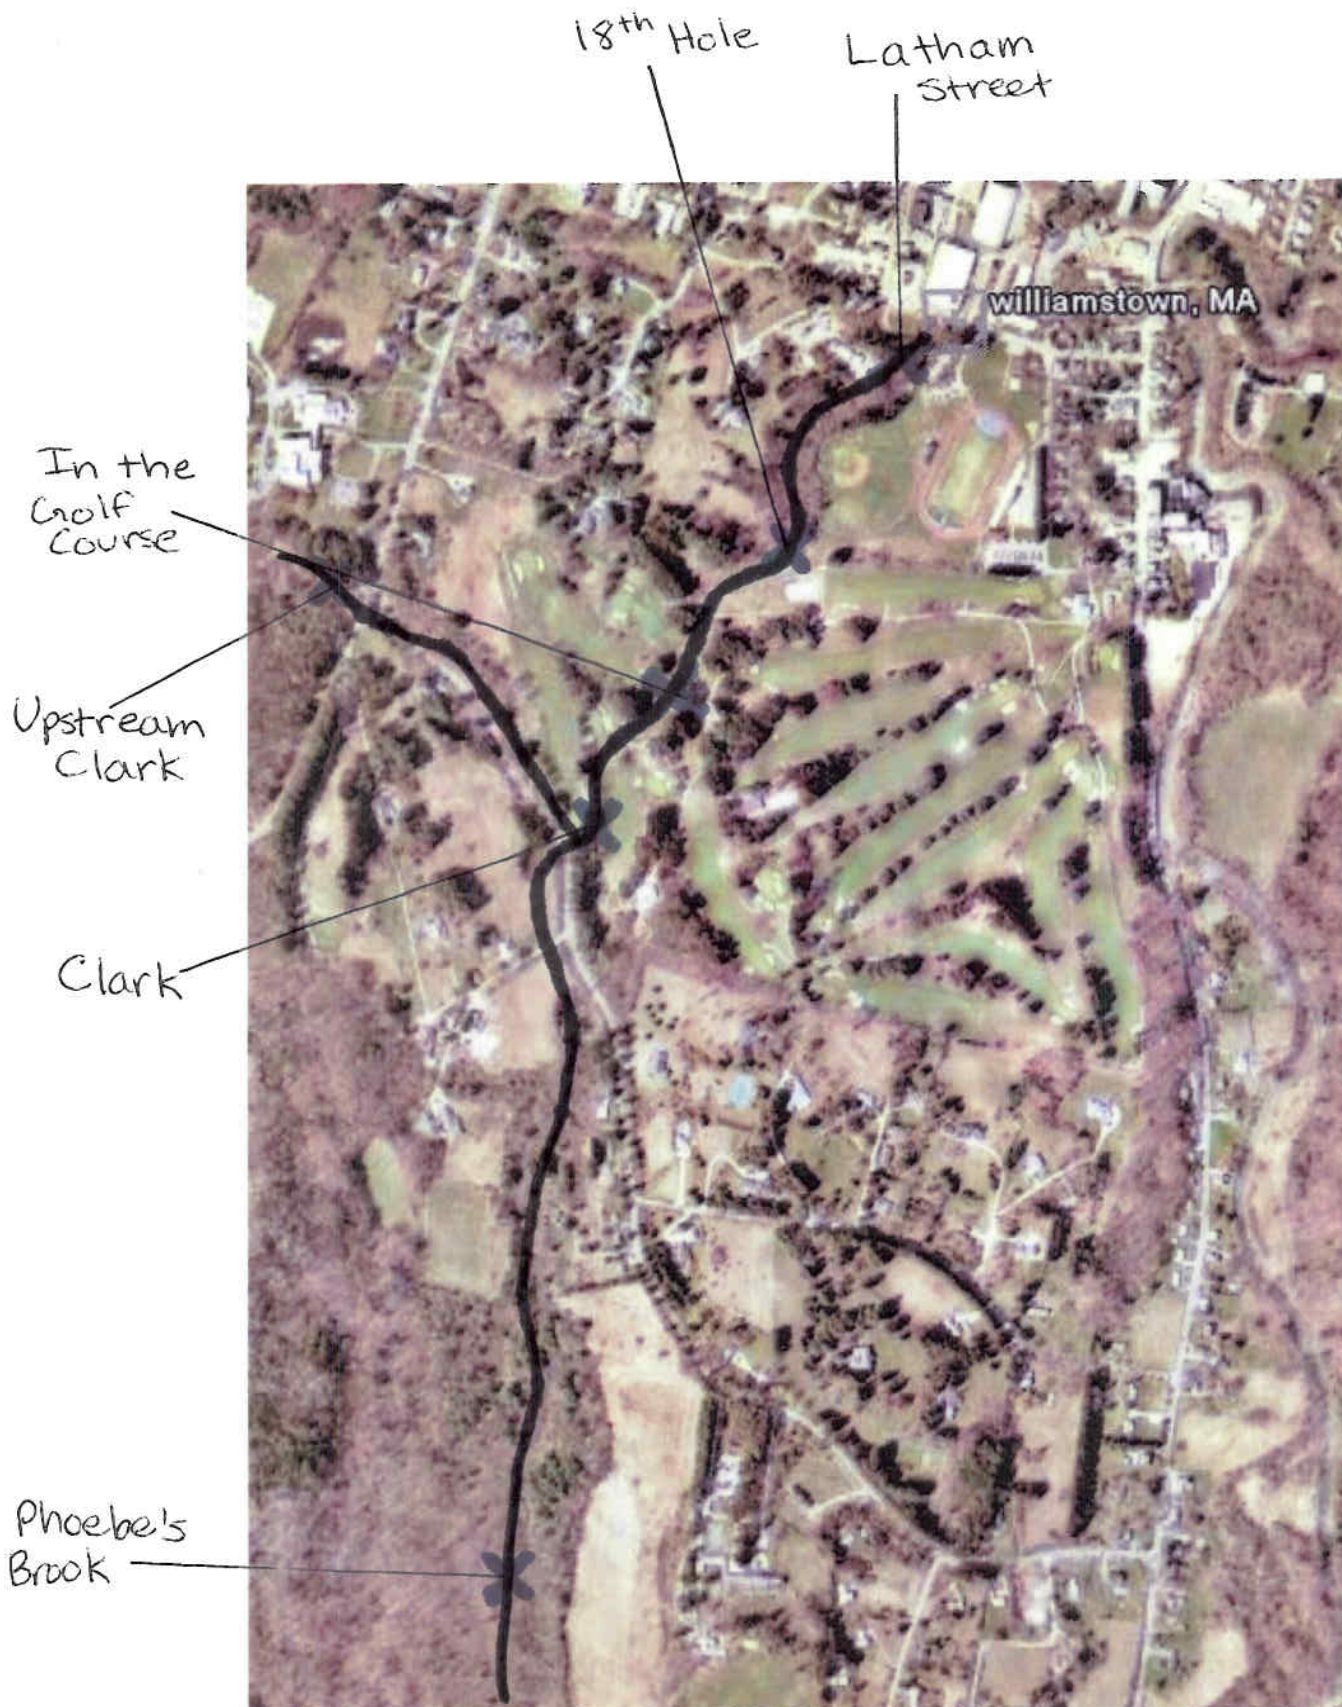
Map 1: Satellite View of Christmas Brook

The headwaters of Christmas Brook form in less densely populated areas before traveling past sites with high human activity.

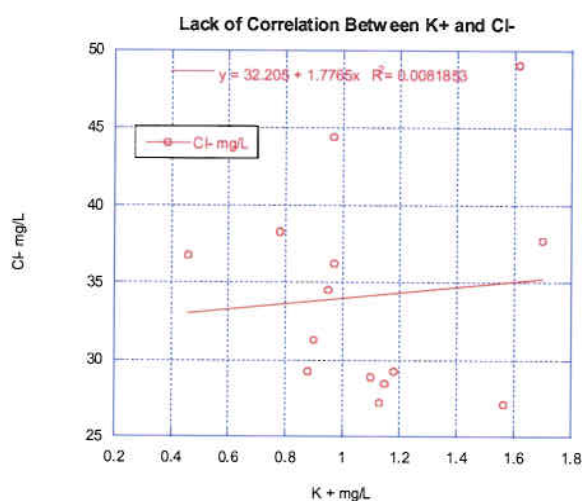
Figure 15

The presence of chloride above 1-2 mg/L, often used as an anthropogenic indicator of human impact, correlates with the presence of sodium ions, pointing to a common source in road salt (Figure 14). If road salt fully explained the correlation, however, we would see a slope in the correlation graph of approximately 1.5. The slope of the graph is 2, indicating an additional source of chloride contamination. Though potassium and magnesium chloride are possible sources, concentrations of these ions do not correlate strongly to chloride levels (Appendix, Figures 15 and 16).

Though the sewer system has reduced contamination from fecal coliform and some chemicals, other aspects of stream health indicate that the sewer has not mitigated all issues of contamination. Samples downstream of the relatively untainted Phoebe's Brook site show higher levels of chloride, sodium, and calcium ions (Figures 10-12). An expected source of both chloride and sodium is NaCl in the form of road salt. As mentioned earlier, all chloride contamination could be accounted for if the ratio between sodium and chloride were around 1.5. We instead found a ratio of 2.0, and therefore believe that there exists an additional source of chloride contamination (Figure 14). We know that $MgCl_2$ and KCl are both commonly used as water softeners in the area, but our data shows little to no correlation between magnesium, potassium, and chloride. Perhaps these small correlations can account for the "extra" chloride, but some unknown source of chloride probably contaminates Christmas Brook (Figures 15 and 16, located at the end of the report).

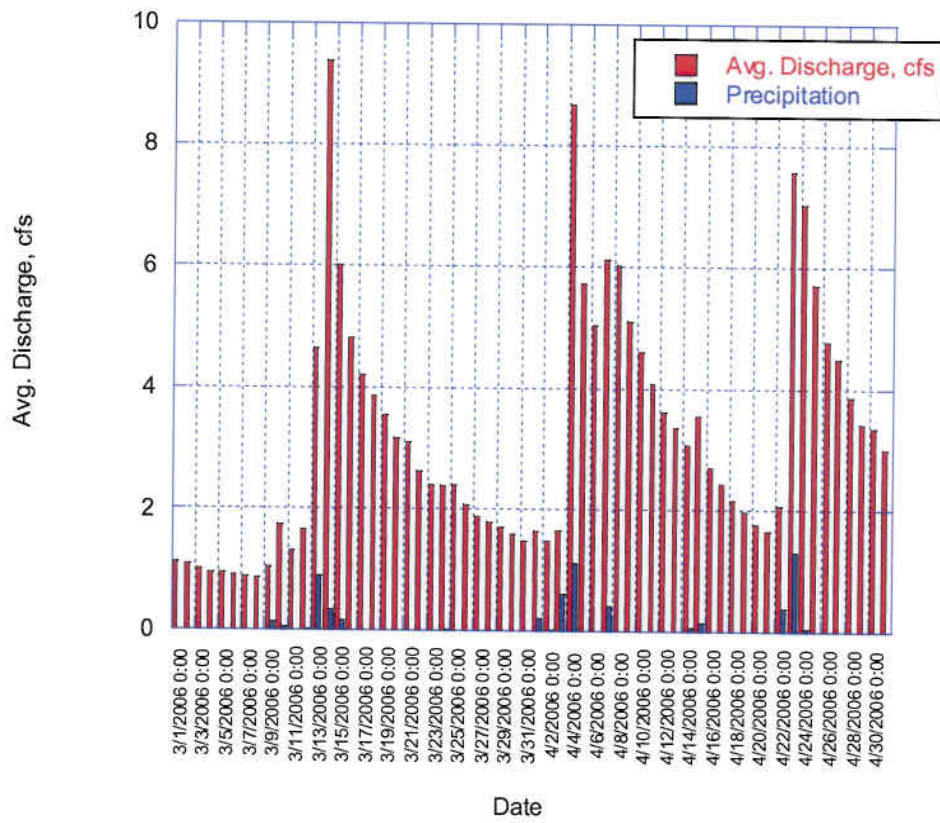
Figure 23

With increased precipitation we observe higher levels of water discharge. Data from the Birch Brook Watershed in Hopkins Forest characterizes this trend (Figure 23). Also, with increased precipitation and discharge, the concentrations of ions within the stream to change, as sediment and other substances are washed into the stream or diluted by rainwater. This relationship allows us to assume that precipitation leads to higher levels of discharge, which may result in dilution or other effects on the chemistry of Christmas Brook.

Discharge Data
