Flora Glen: A Second (and third, and fourth) Look

Brenna McDonald
ENVI 102
Profs, Art, Dethier, and Evans
May 18, 1992

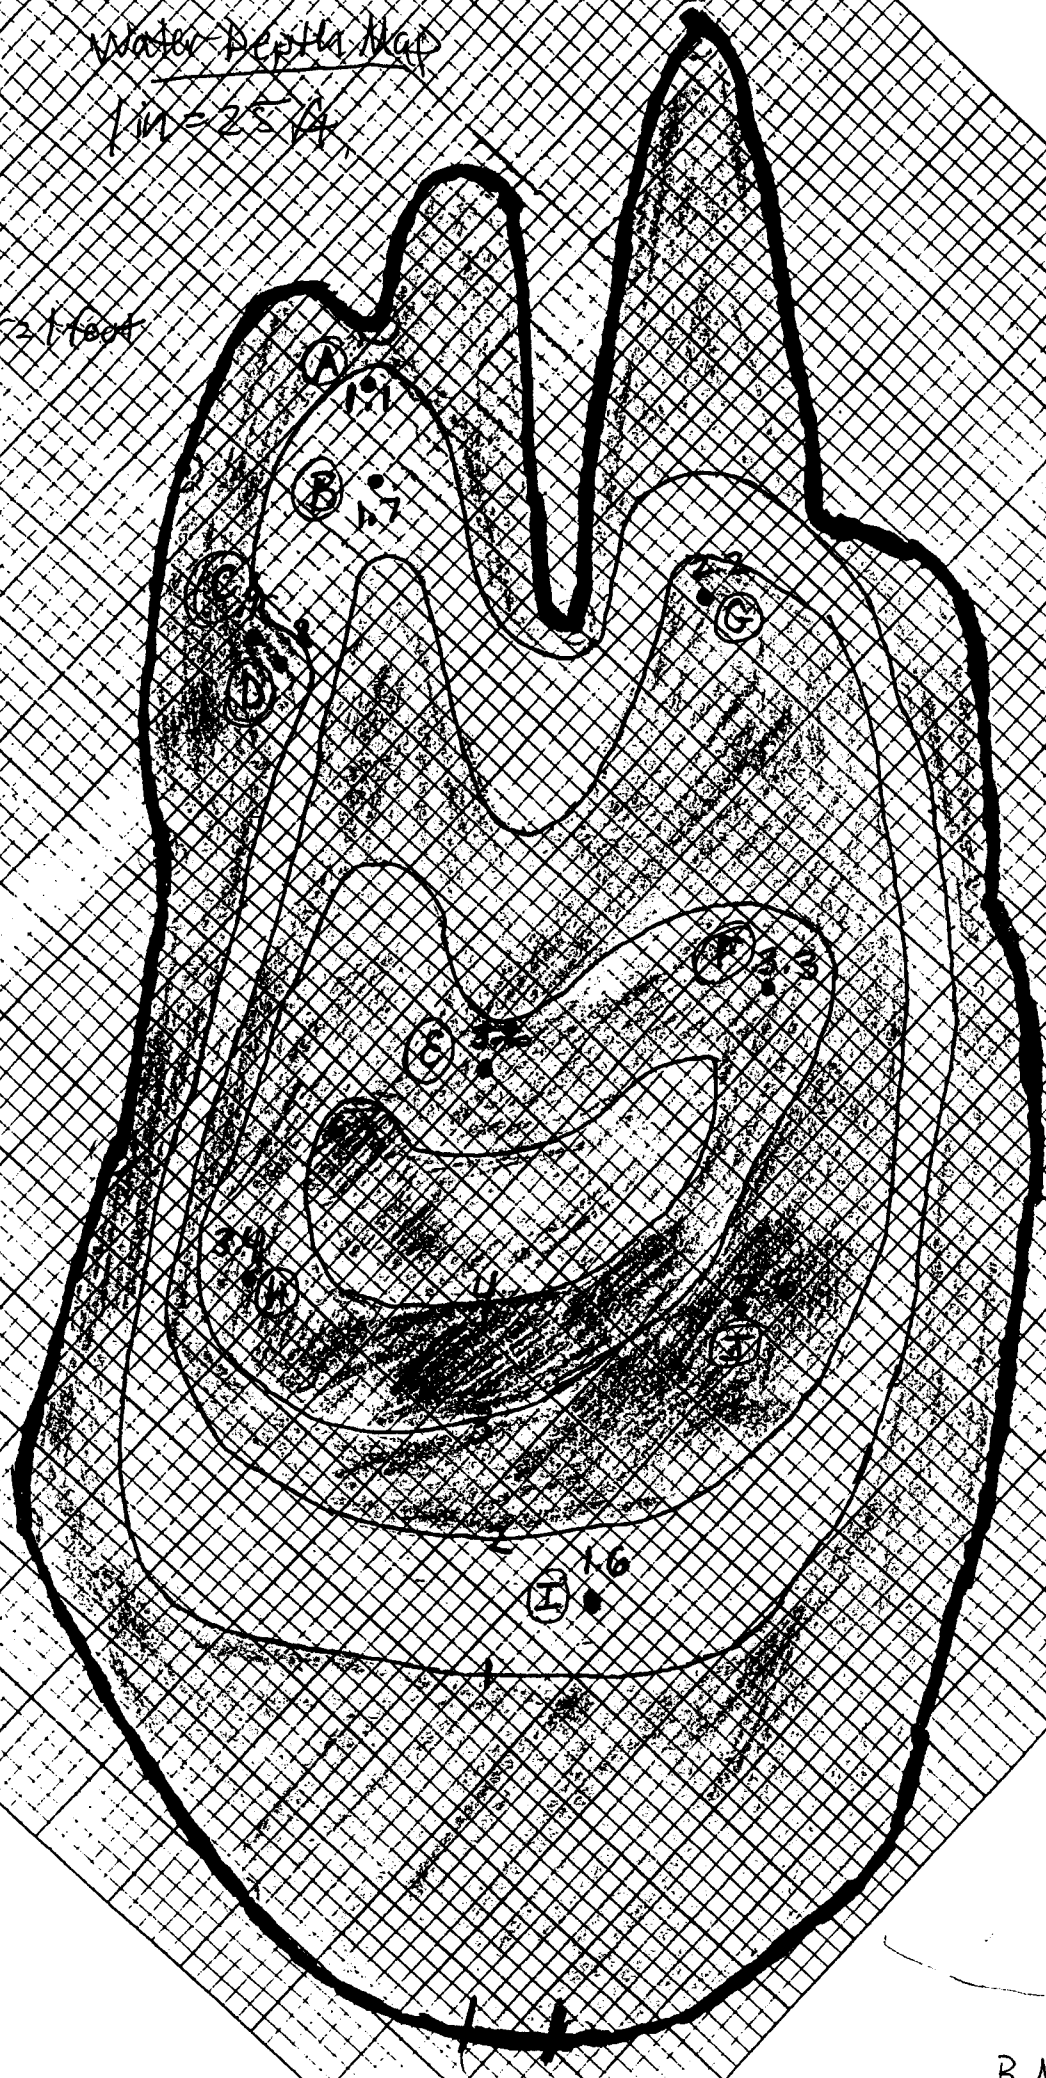
Water Depth Map

The actual contents of the pond, both water and sediment, show many interesting patterns. Water depth never extends below four or five feet. The water is deepest at what is roughly the center of the pond, and gradually becomes shallower as one moves towards the edges of the pond. The eastern end, that feeding directly into the waterfall, is the shallowest, having a depth of less than one foot for a distance of fifty feet before the outflow (see water depth map for detailed representation of the various water depths). The water flow is a fairly direct one, from inlet to outlet, so much of the surface water does not appear to be moving at times. In the two fingers of water formed by the protrusion of the peninsulas, the water is completely stagnant, and filled with algae. This algae extends somewhat to the periphery, as its evidence in sample three shows.

1 in = 25 ft

Each contour 3 feet

To find water and sediment depths, both people went out on the pond in the boat, and one held the boat still with a probe, while the other used another probe and the measuring tape to find the actual depths. These depths were plotted on a map of the pond (see water and sediment depth maps), and bathymetry lines were drawn for the various depths. The areas of the individual sections were multiplied by an average of the possible depths (increments of one foot, starting at 0.5 feet were used, except for the 0-1ft portion of the sediment, as multiple points could be used to weight the average in this case) to obtain the volume of the pond's water and sediment. The volume of water was thus found to be approximately 3.48×10^4 cubic feet, and that of sediment to be 2.01×10^4 cubic feet (see

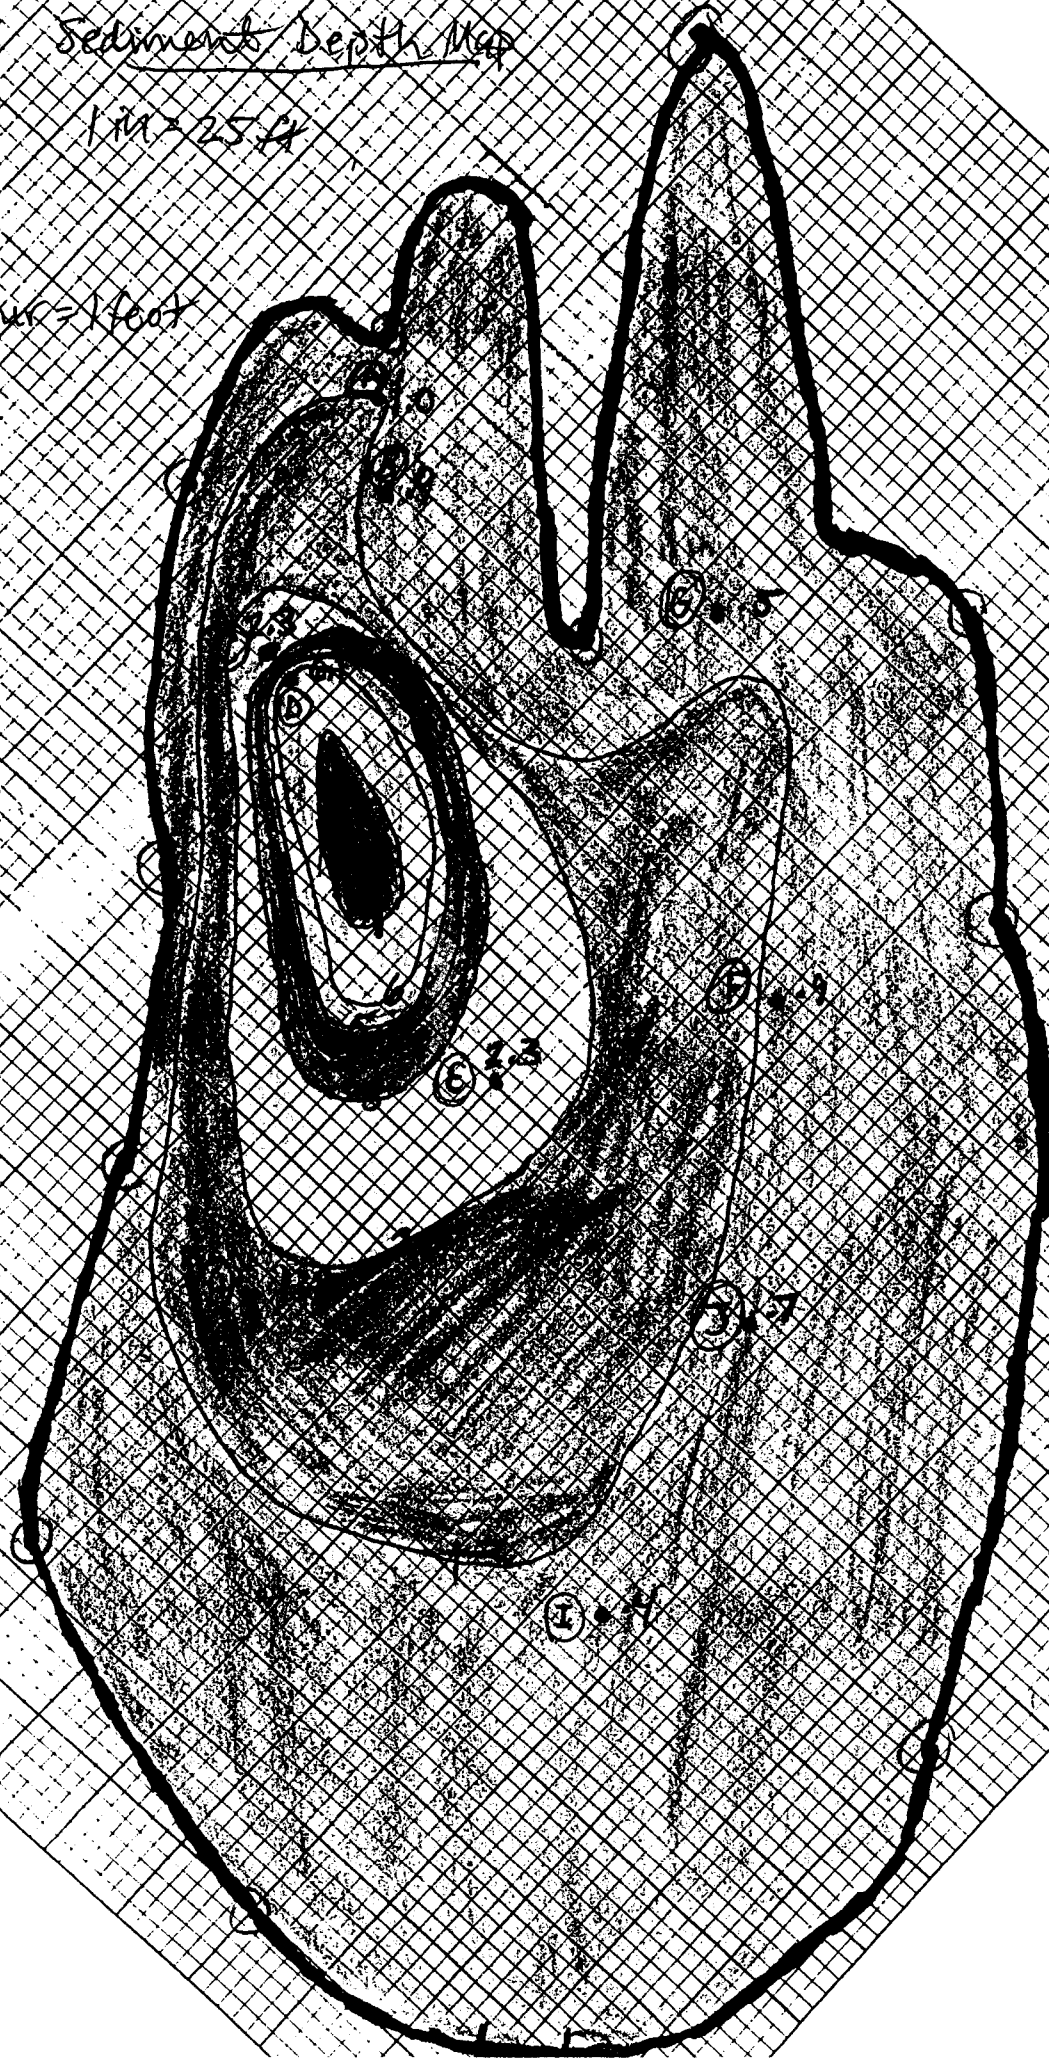
Sediment Depth Map

The pattern for sediment depth varied from that of water. The sediment was deepest more towards the inlet, which seems logical, since much sediment enters in this manner (perhaps some also enters the pond through erosion). With the exception of the southeastern side of the pond, the sediment at the edge of the pond was less than a foot deep for a distance of roughly twenty-five to sixty feet around the periphery of the pond. Here there is an interesting point to notice. Between points C and D, there is a noticeable increase in sediment depth, from 2.3 to 6.1 feet, in a distance of only one foot. This can be explained by a flooding of the pond due to the storm on May 2, 1992. Site C is not usually submerged, and therefore the water has not penetrated to such depths as it has at site D, which is always under water. Also, the sediment in the southern finger is colored orange, indicating a possible leakage of copper from the ground in this area, which may be of natural or human origin.

1 in = 25 ft

Each contour = 1 foot
