Susannah Shmurak
Enviro Science 102
Prof. Kegley
May 10, 1991

Why can't we swim in the Pequabuck?

The Pequabuck River in the Farmington Valley ^{of CT.} has been off limits to swimmers for a number of years now, and this project investigated why. Samples were taken from a number of sites along the river and analyzed in lab for a number of contaminants that would make swimming unhealthful to bathers.

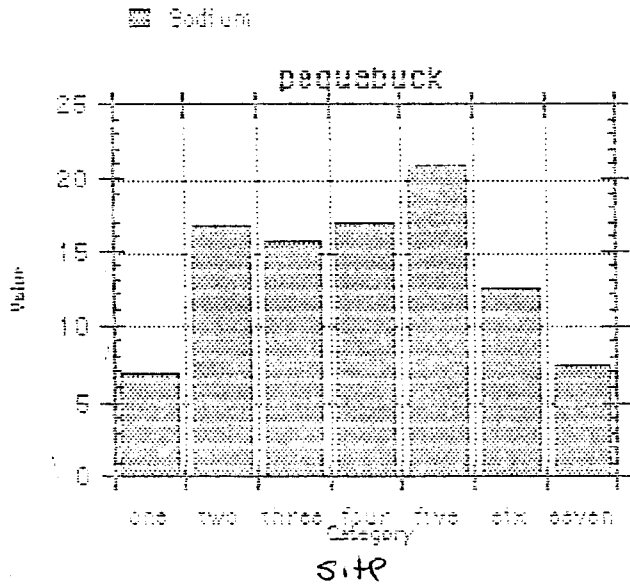
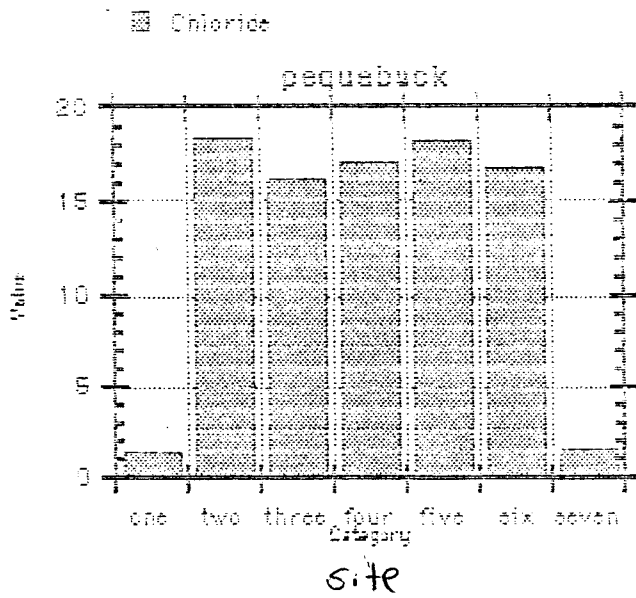
Fig 4. Graphs of Na^+ , K^+ , Cl^- , F^- ions
at each site sampled

The samples were diluted 1: 10, and run through the atomic absorption spectrometer. Table 2 lists the adjusted numbers.

Samples were run through the ion chromatograph straight and diluted by 1:10. Table 3 lists the results.

It is obvious in looking at the data that the water of the Pequabuck is not healthy. The lowest coliform count is just at the allowable level for swimming; the others are extremely dangerous for bathers, with counts as high as 1700 and 2500. The levels of sodium are also unusually high, with normal levels of river water being 4 mg/L or less- these samples yielded levels as much as five times as great. Potassium levels, too, were high. Normal levels of potassium are between 0.2 and 1.5 mg/L; levels for the Pequabuck ranged from 0.8 to 2.5. In addition, chloride readings were unusually high, with the normal being between 0.3 and 0.4 mg/L- readings from the Pequabuck went as high as 18.3. Nitrate readings were also well

It is interesting to note that the sites 2 through 6 follow consistent patterns, as do 1 and 7. Site 1 is located before the Pequabuck empties into the Farmington, and thus does not show the same signs of pollution as the waters of the Pequabuck. Site 7 is at the head of the Pequabuck, before it has passed by all the industrial parks who utilize and dump into the water, and shows very similar readings to those of the Farmington. Sites 2 through 5 all have similar readings for chloride and nitrate, all extremely high, though there is more variation in the readings for these five samples for sulfate, which are also unnaturally high. A look at the graphs confirms these facts, with the lowest readings for all the ions and the coliform in the first and last sampling, the untainted samples, and the highest in the middle four or five, reflecting the way the water is used by the towns along

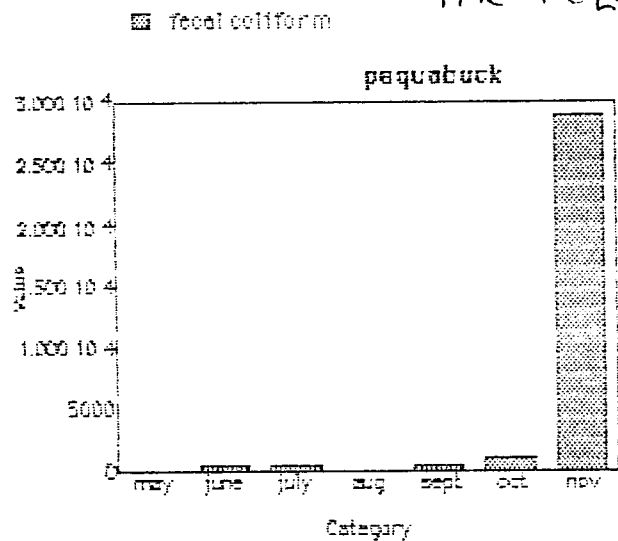
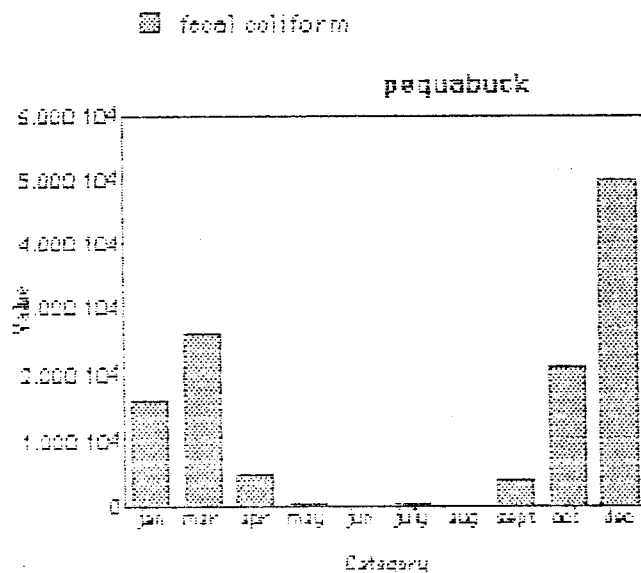
Fig 6. U.S. Geo. Survey of fecal coliform levels in the Pequabuck, 1981-1985 *

* Samples were not taken every month of every year.

The Pequabuck consistently had unusually high readings of fecal coliform in the site where the researchers sampled, the result of which is the prohibition of swimming, much less drinking from the river. These results can be found in the graphs of figures 6 and 7. Water bodies are classified as A, B, C, and D, A being of drinking quality, with two fecal coliforms per 100 milliliters or less; B being suitable for swimming, but not drinking, with 200 coliforms or fewer; C being good for industrial use only; and D, unsafe for all of the above. ^{reference} Commonly, the Pequabuck has levels of fecal coliform hundreds of times higher than those that are safe for swimming.

The U.S.G.S study on the Pequabuck also tested for fecal coliform- graphs of their findings from 1981 to 1989 are in figures 6 and 7. At certain times in the year coliform counts were as high 170,00¹⁰⁰/ 100ml water (Jan 1984), though they also went as low as 24/ml (May 86).

The U.S. Geologic survey along the Pequabuck has discovered amazing amounts of coliform bacteria, which are graphed for the years 1981 to 1990 in figures 6 and 7. May, June and July are consistently the months with the lowest levels of coliform, the highest levels being in November, December and January, and October of 1988. Temperature certainly has something to do with this, but the opposite of what one might expect is true. Warmer temperatures should culture a greater number of bacteria, and colder temperatures should inhibit their growth. Perhaps it is just this fact that the sewage treatment plant takes into account, and disposes of its wastewater elsewhere. In any case, it is notable that in most years, in the summer months, the months a river might be used for bathing, the levels of coliform were acceptable under health regulations. It is only during the winter months that the outrageously high levels were found.

It also appears looking at U.S.G.S findings that the levels at their highest are finally going down. The highest reading for 1989 was 1400 in December- compared with the December readings previous, 80,000 in 1982, 50,000 in 1983, 380,000 in 1985, 110,000 in 1986, and 29,000 in 1988, the levels have dropped appreciably. However, at their worst, the levels are still completely unacceptable, and Connecticut must put stricter regulations on the sewage treatment centers, because these amounts of coliform do not belong in a river.

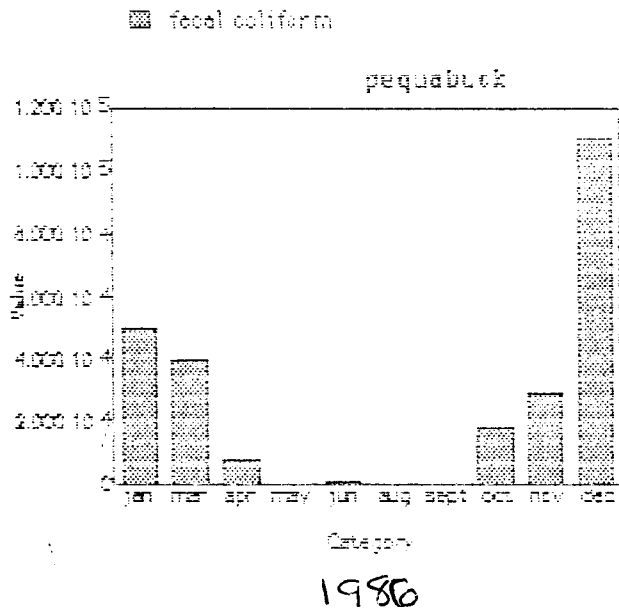
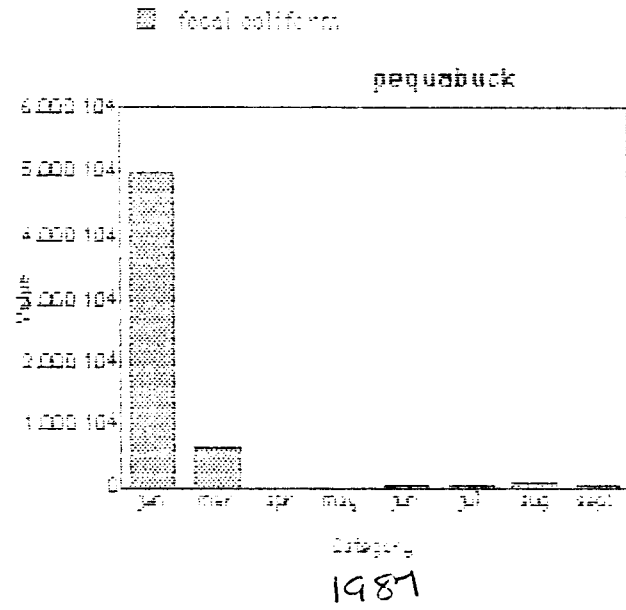
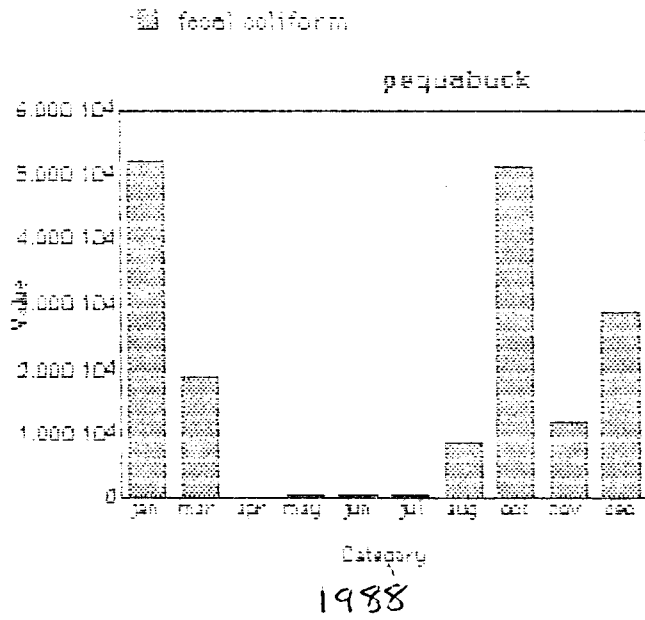
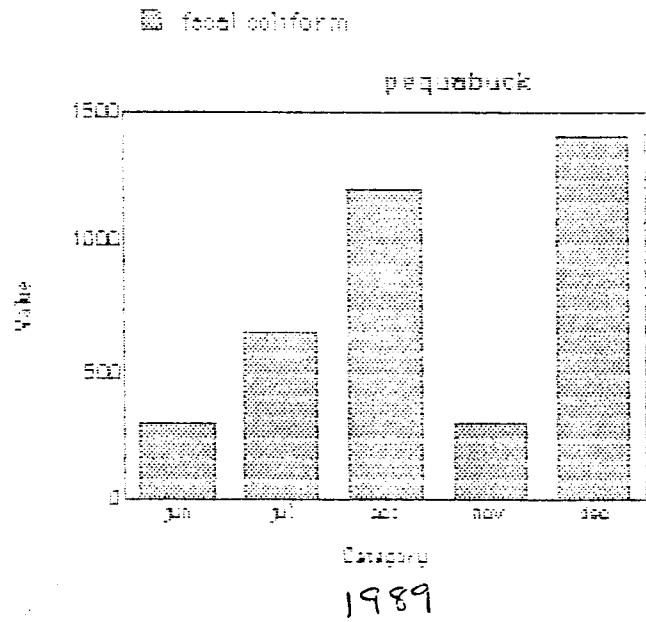
Fig 7. U.S.G.S. fecal coliform levels in the Pequabuck,
1986 - 1989
