### Saw Mill River:

the effects of urbanization on water quality

Irene Gruenfeld Environmental Science 102 Professor Susan Kegley May 10, 1991

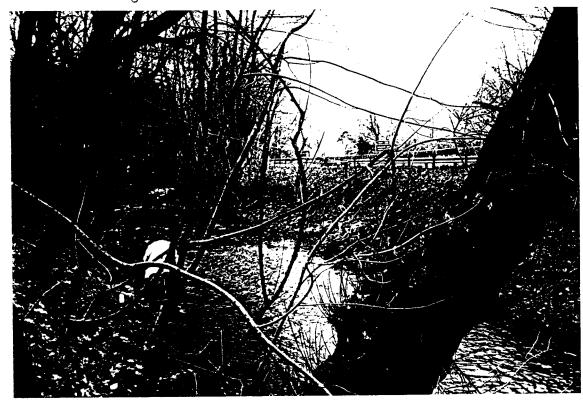
intersection of Bedford Road and Saw Mill River Parkway

The second sample was collected at the intersection of Bedford Road and the Saw Mill River Parkway at approximately river mile 19. The river is faster flowing here and in the small wooded area alongside the river there is considerable litter including oil cans, wrappers, and paper.

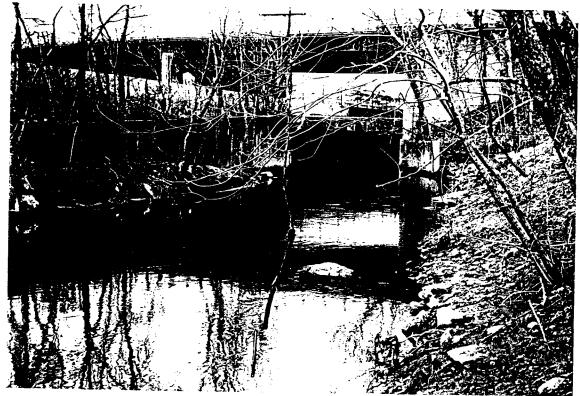
1 Ardsley Flood Prevention Control Channel

Between sampling points 4 and 5, the basin is largely residential except for the Ardsley business district. The Ardsley business district is comprised of several stores and professional buildings, and RSA Corporation Research Laboratories which is a custom manufacturer of chemicals with no discharge into the river. Rum Brook enters the Saw Mill River north of Ardsley. In Ardsley, the river flows through an open concrete channel which is part of the Ardsley Flood Control Project. For the length of this section, the river runs parallel to the New York State Thruway.

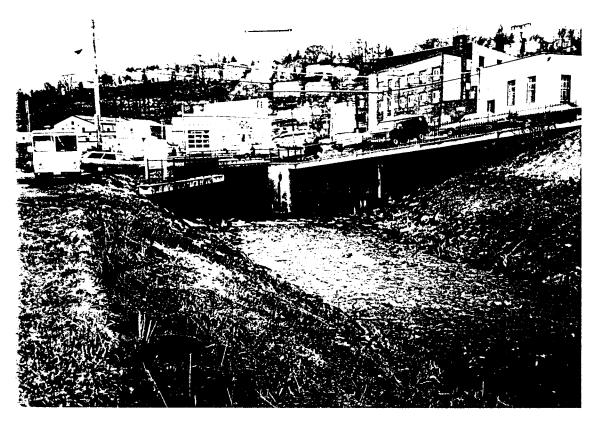
# Sampling point 7 Cld Nepperhan Avenue

The busy intersection of Nepperhan Avenue and Old Nepperhan Avenue, near river mile 3, is the site of sampling point 7. Here the water is very fast flowing and the banks are fairly steep. As the river flows under Old Nepperhan Avenue it enters a 1.5 mile long concrete channel which is part of the Yonkers Flood Control Project.

beginning of 1.5 mile Yonkers Flood Prevention control Channel

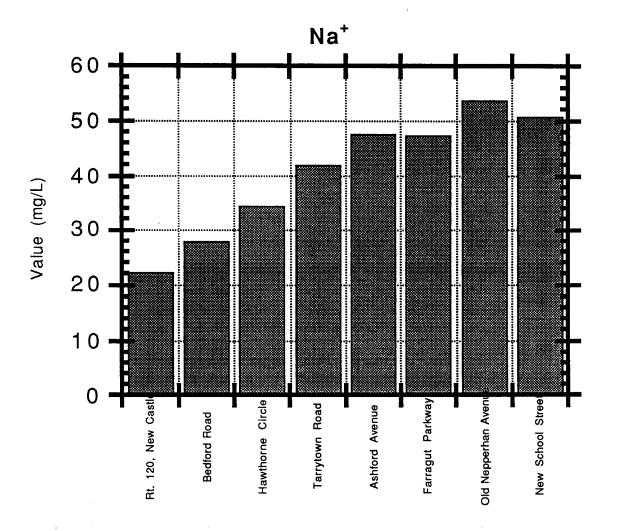
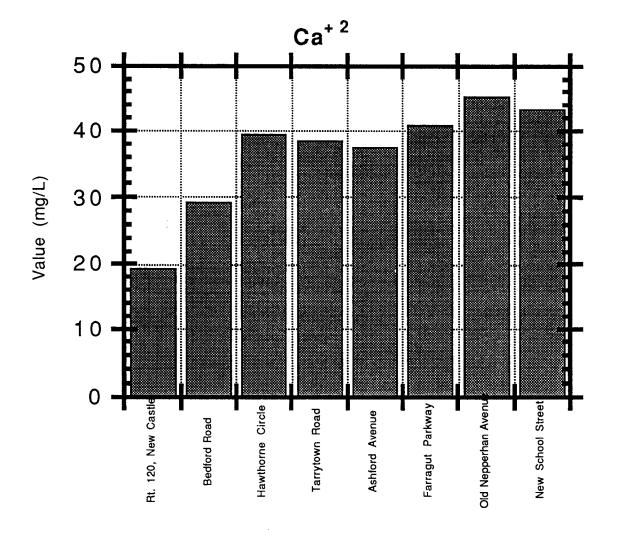
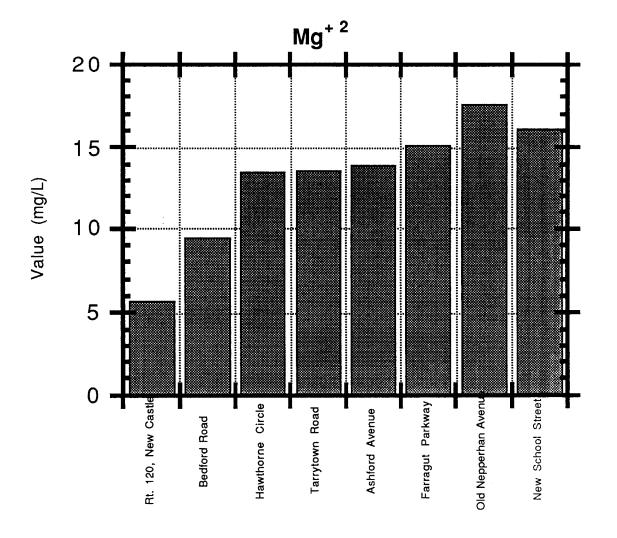
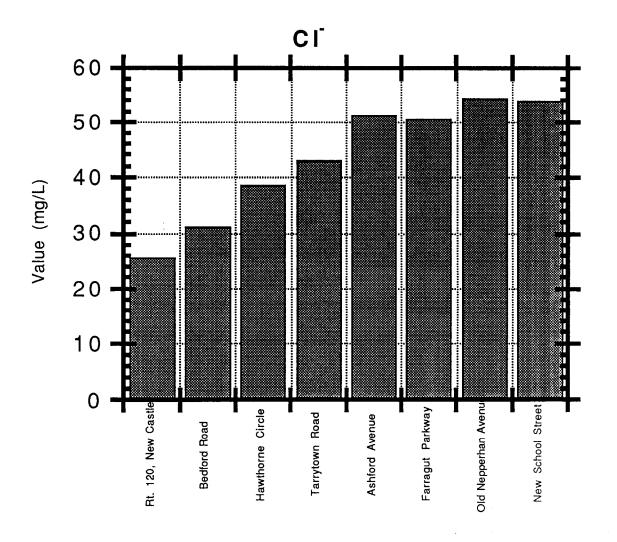
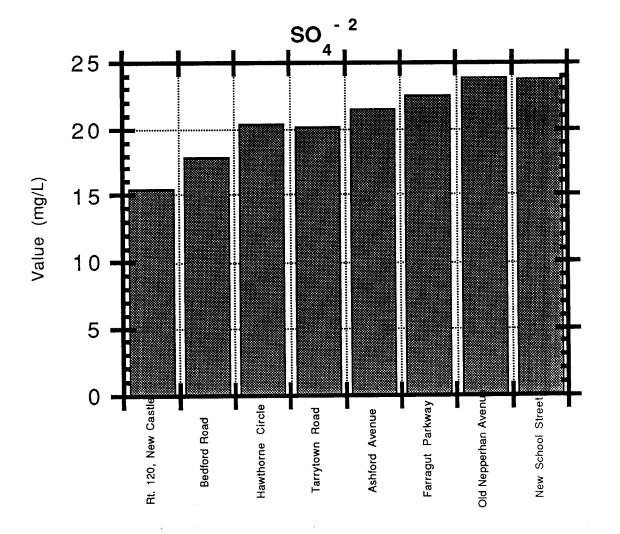
Levels of sodium, calcium, magnesium, chloride, and sulfate increase substantially between sample point 1 and sample point 8 indicating a downstream deterioration in water quality. (see figures 1-5) These cations and anions seem to be steadily entering the system. Therefore, they are probably entering through runoff and not coming from any particular point sources. It is interesting to note that each of these substances reaches its peak at sampling point 7, not sampling point 8. This may be due to the fact that for most of the distance between points 7 and 8, the river flows through a concrete flood prevention structure that probably prevents a lot of urban runoff from entering the river. Potassium and nitrate values do not seem to reflect any trend in relation to location.

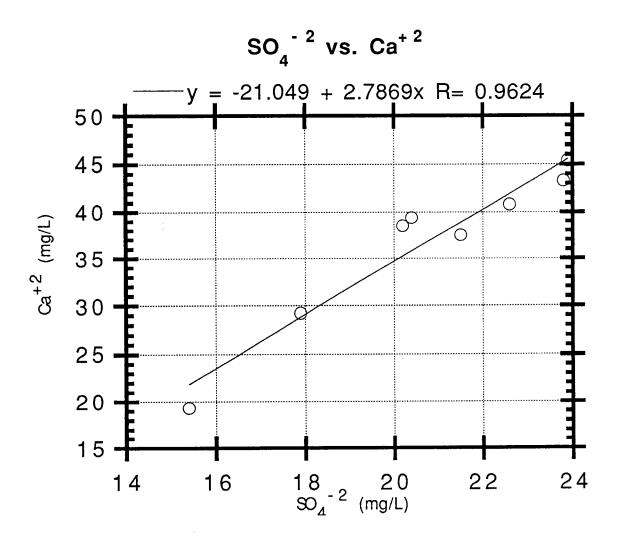
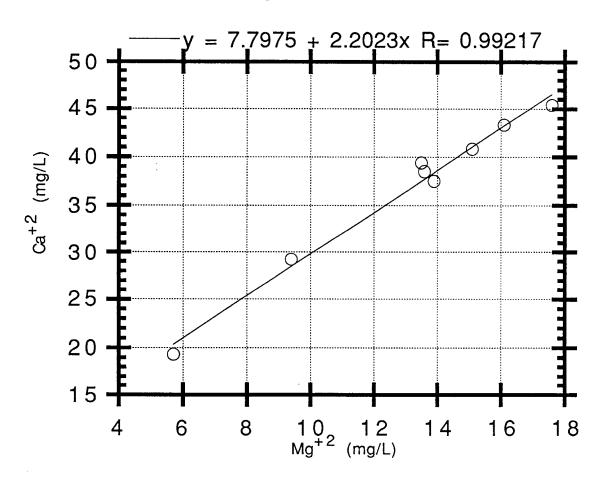
${\rm Mg}^{+\,2}$  vs.  ${\rm Ca}^{+\,2}$

Correlations between certain of these anions and cations help to explain the high levels found in the Saw Mill River. For instance, there are strong correlations between the values for sulfate and calcium and between the values for magnesium and calcium. (see figures 6 and 7) This confirms the existence of dolomite (Ca2MgCO3) in the basin and suggests that there is also gypsum (CaSO4) in the area.

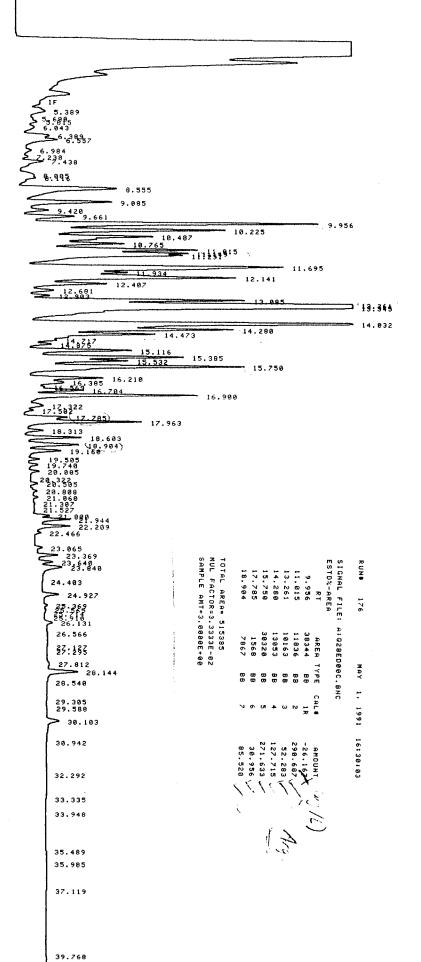
Sample 4-PCB calculations

<u>Cal</u> *	dry value (290.687 mg/l) (10 ml) (1600ml) = 2.90687 mg
	$\frac{2.90687 \text{ Mg}}{0.02289 \text{ kg}} = 126.99 \text{ ppb}$
3	0.52283 mg = 22.84 ppb
4	1.27715~119 = 55.80 ppb 0.02289 kg
5	2.71633 mg = 118.67 ppb 0.02289 kg
6	0.30956 mg = 13.52 ppb 0.02289 kg
7	0.85520 mg = 37.36 ppb 0.02289 kg

avg. dry concentration = 62.53 ppb

PCB levels in the sediment of the Saw Mill River are also alarming. PCB concentrations rise almost five fold between points 4 and 6. The level then doubles between points 6 and 8. (see figure 20) This indicates that either the PCBs are coming from one point source north of Elmsford, probably the capacitator burial ground, and collecting in the sediments downstream or that they are originating from a few sources. In 1976, a report published by the U.S. Geological Survey indicated that no PCBs were detected north of Elmsford and that PCB contamination at sampling point 4 was 38

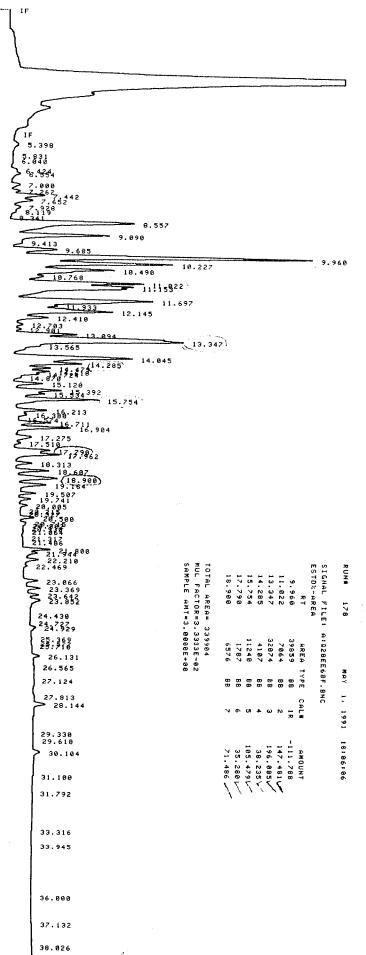
## Sample 8-PCB calculations

July 2	
Cal #	dry value	
2	1.47481 mg = 61.48 ppb x 16	
	0.02399 kg	
3	1.96085 Mg = 81.74 ppb x 10	
	0.02399 kg	
4	0.38235 Mg = 15.94 ppb x10	
	0.02399 tg	
5	1.05479 mg	
	1.05479 mg = 43.97 ppb x 10	
6		
	0.35286 mg 0.02399 kg = 14.71 ppb × 16	
	0.02399 kg	
1	0.71486 reg	
	0.71486 mg = 29.80 ppb×10

avg. dry concentration = 412.73 ppb
